Expertise

Protocol number: 46315606
Order No. / Reference: 26527816
Inspection date: 3 Jul 2026

Manufacturer: Opel

Model: Astra 1.2 Turbo Automatik Business Elegance

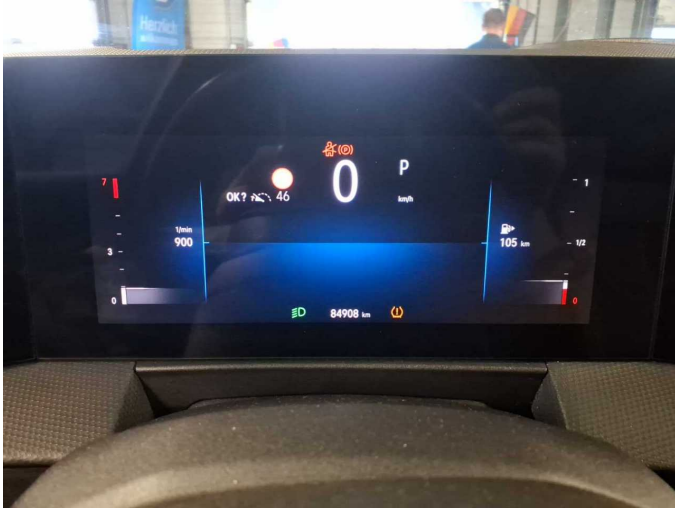
Figure 7: Instrument cluster

No.	Component group	Description
1	2nd wheel set	1 alloy rim (gehört nicht zur Ausstattung) - Scratched - No deduction
2	Instrument panel	Indicator light (Reifenfruck) - on - Perform diagnosis
3	Engine	Engine cover - Damaged - Replace
4	Wheel / tyres	Tyre - front right side (Flanke) - Damaged - Replace
