Expertise

Protocol number: 46495109  
Order No. / Reference: 26694886  
Inspection date: 13 Jul 2026

| Manufacturer: Volkswagen | Model: ID. Buzz Pro |
| VIN: WV2ZZZEB9PH017632 | |

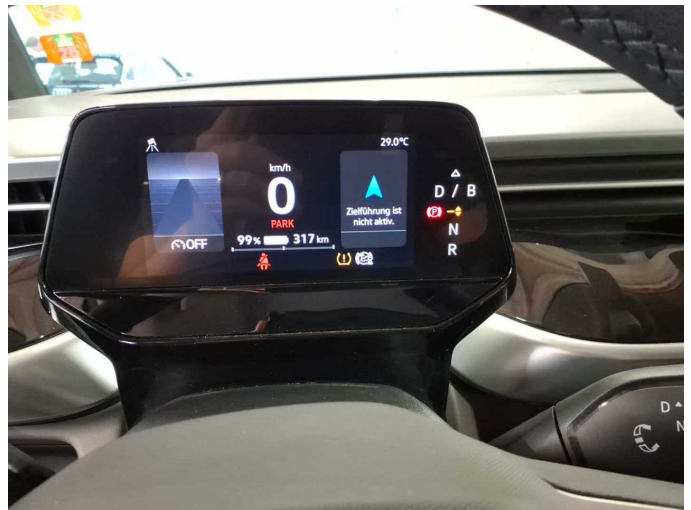
| No. | Component group | Description |
|---|---|---|
| 1 | Instrument panel | Indicator light (RDKS) - on - Diagnosed and repair if necessary |

**Damage 1:** Instrument panel: Indicator light (RDKS) - on - Diagnosed and repair if necessary

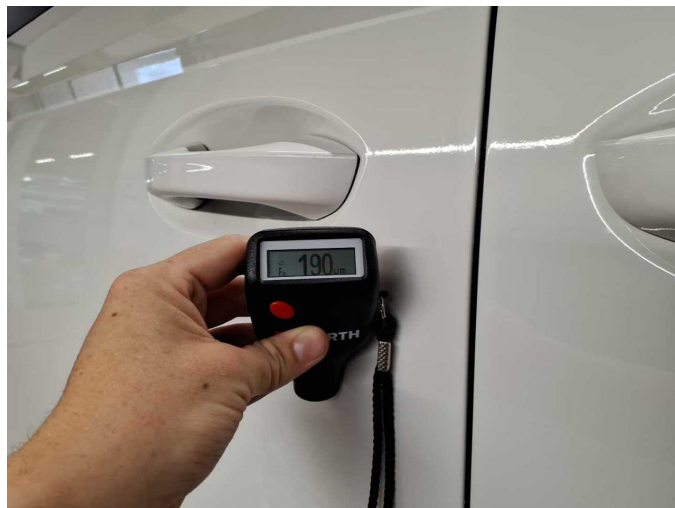
**Repainting 3:** Door - rear right side
