Expertise

Protocol number: 46145875
Order No. / Reference: 26518192
Inspection date: 17 Jun 2026

Model: Transit Connect 230 L2 S&S Trend

VIN: WF07XXWPG7NY73116

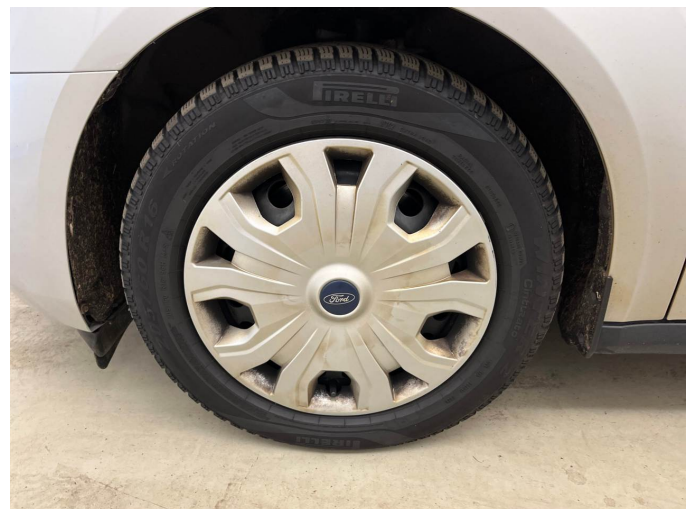
Figure 12: Mounted tyres

Mounted tyres				
#	Tyre size	Type of tyre	Manufacturer	Tread depth
1)	205/60 R16 96H	Winter tyres on Steel rim with wheel cover	Pirelli	4mm / 4mm
2)	205/60 R16 96H	Winter tyres on Steel rim with wheel cover	Pirelli	3mm / 3mm

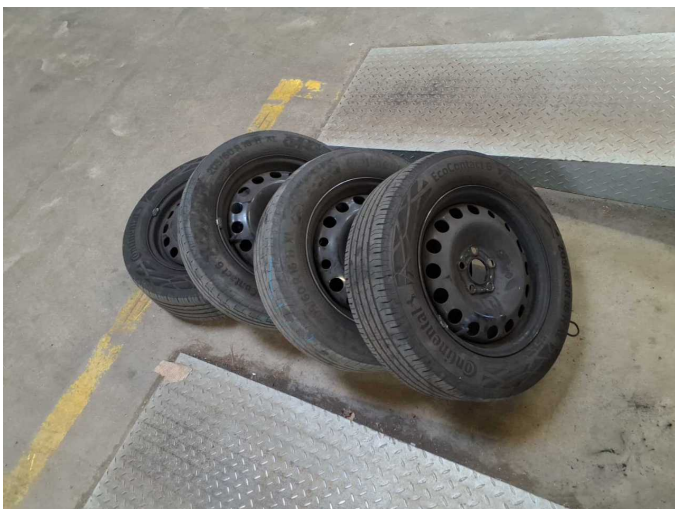
Figure 17: Additional tyres

- Für den montierten Radsatz wurde kein Nachweis erbracht.

- Winterradsatz ist kein Bestandteil des Auslieferungsumfangs.
