Expertise

Protocol number: 46150641
Order No. / Reference: 26497104
Inspection date: 16 Jun 2026

Model: 3008 BlueHDi 130 Stop & Start EAT8 Active Business-Paket

VIN: VF3MCYHZRLS191689

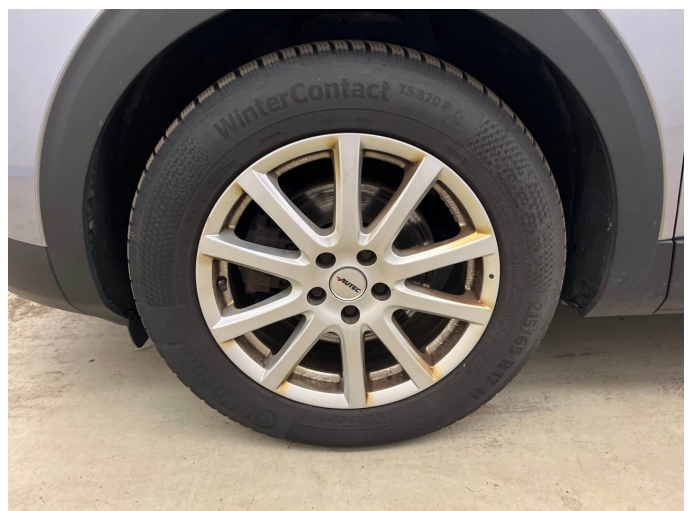
Figure 12: Mounted tyres

Mounted tyres				
#	Tyre size	Type of tyre	Manufacturer	Tread depth
1)	215/65 R17 99H	Winter tyres on Light alloy	Continental	5mm / 5mm
2)	215/65 R17 99H	Winter tyres on Light alloy	Continental	5mm / 5mm
Additional tyres				
#	Tyre size	Type of tyre	Manufacturer	Tread depth
1)	215/65 R17 103V	Summer tyres on Light alloy	Michelin	5mm / 5mm
2)	215/65 R17 103V	Summer tyres on Light alloy	Michelin	5mm / 5mm
Replacement				
Typ	Tyre size	Type of tyre	Manufacturer	Tread depth
	Tirefit	Expiration date 01/2025
