Expertise

Protocol number: 45860200
Order No. / Reference: 26379565
Inspection date: 3 Jun 2026

Manufacturer: CUPRA

Model: Born 150kW/58kWh

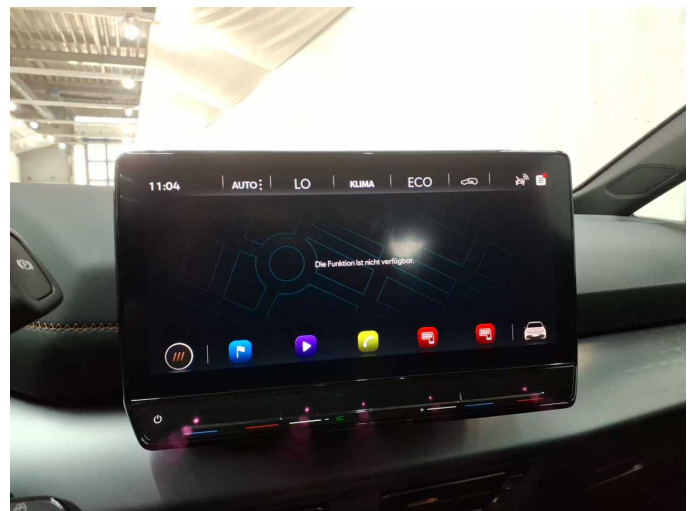
Figure 16: Navigation

Damage 2: Multimedia system: Navigation system - Non-operational - Perform diagnosis
