Expertise

Protocol number: 46311703
Order No. / Reference: 26412168
Inspection date: 1 Jul 2026

Model: Focus Turnier 1.0 EcoBoost Start-Stopp-System TITANIUM

VIN: WF0PXXGCHPNG35445

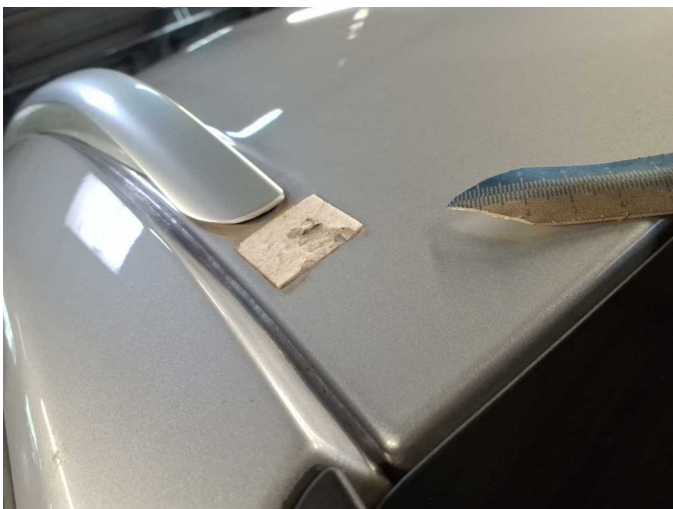
Damage 5: Roof: Roof - Glued / labelled - De-glu / neutralise

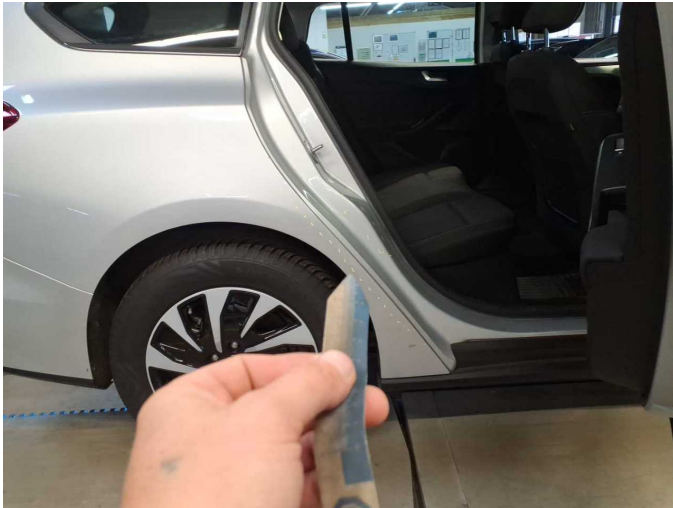
Damage 15: Side panel - rear right side: Side panel (+ Einstieg) - Scratch(es) - Smart repair

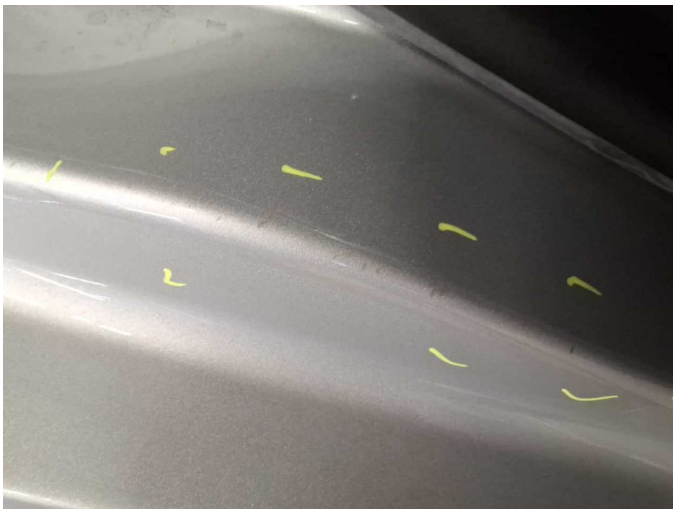
Damage 15: Side panel - rear right side: Side panel (+ Einstieg) - Scratch(es) - Smart repair

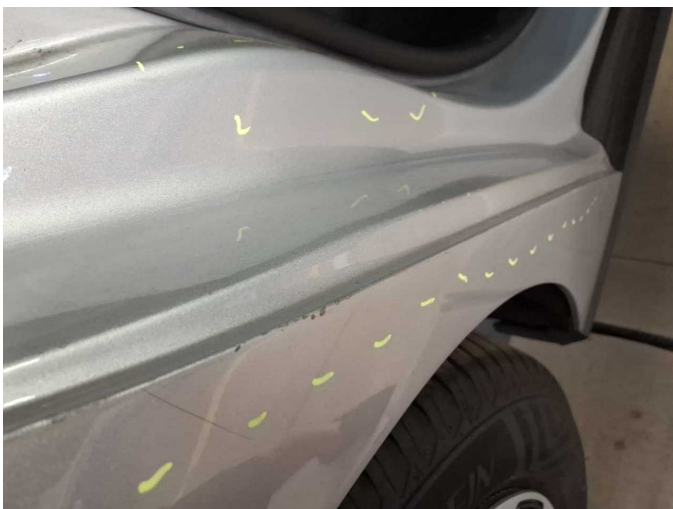
Damage 15: Side panel - rear right side: Side panel (+ Einstieg) - Scratch(es) - Smart repair
