Expertise

Protocol number: 46710467  
Order No. / Reference: 26759860  
Inspection date: 24 Jul 2026

| Manufacturer: Mercedes-Benz | Model: C 220 d T 9G-TRONIC AMG Line |
| VIN: W1KAH0EB7PF114324 | |

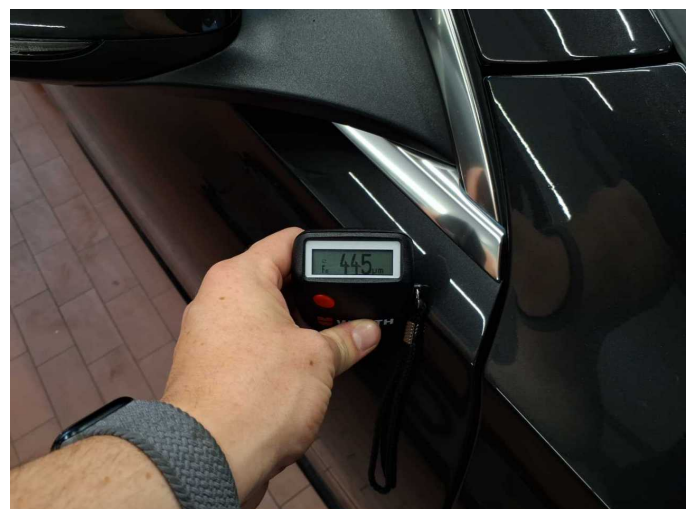
**Repainting 2: Door - rear right side**
