Expertise

Protocol number: 46376166  
Order No. / Reference: 26653128  
Inspection date: 6 Jul 2026

Manufacturer: Citroën

Model: C5 Aircross Hybrid 136 ë-DSC6 MAX

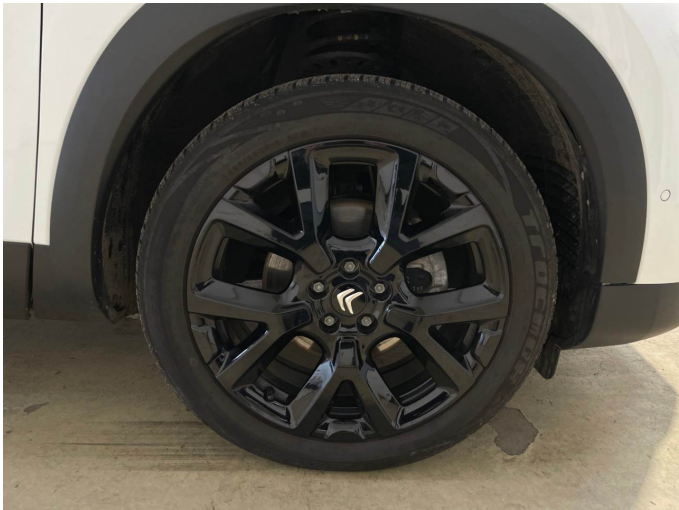
Figure 12: Mounted tyres

| # | Tyre size | Type of tyre | Manufacturer | Tread depth |
|---|---|---|---|---|
| 1) | 205/55 R19 97W | All-season tyres on Light alloy | Sonstige | 5mm / 5mm |
| 2) | 205/55 R19 97W | All-season tyres on Light alloy | Sonstige | 6mm / 6mm |
