Expertise

Protocol number: 45332733
Order No. / Reference: 26292138
Inspection date: 4 May 2026

Model: 317 CDI Sprinter Standard HA 9G-TRONIC PRO

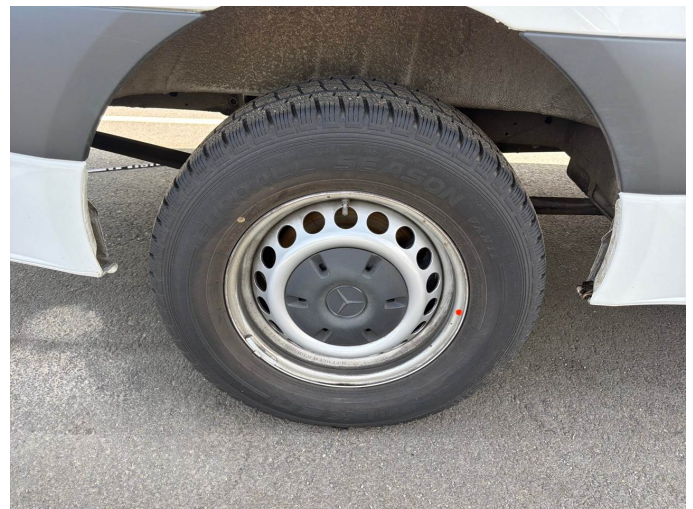
Figure 12: Mounted tyres

#	Tyre size	Type of tyre	Manufacturer	Tread depth
1)	235/65 R16 115R	All-season tyres on Steel rim with wheel cover	Falken	6mm / 6mm
2)	235/65 R16 115R	All-season tyres on Steel rim with wheel cover	Falken	6mm / 6mm
