Expertise

Protocol number: 45449892
Order No. / Reference: 26368233
Inspection date: 8 May 2026

Model: Astra 1.5 D Automatik Business Elegance

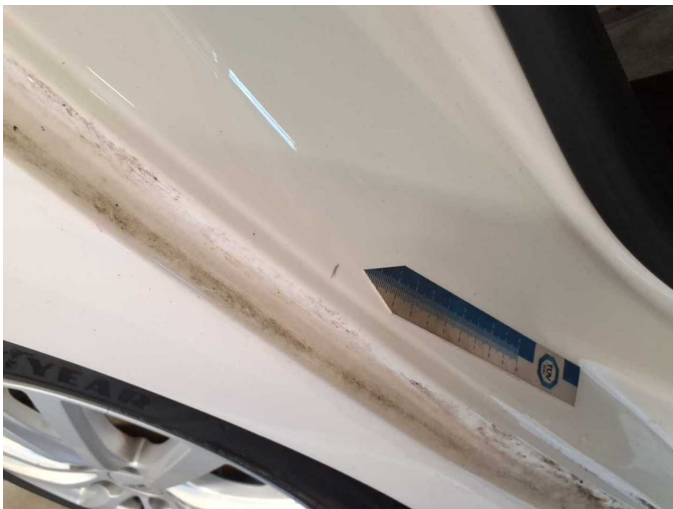
Damage 13: Side panel - rear right side: Sill - Dent / paintcoat damage - Smart repair

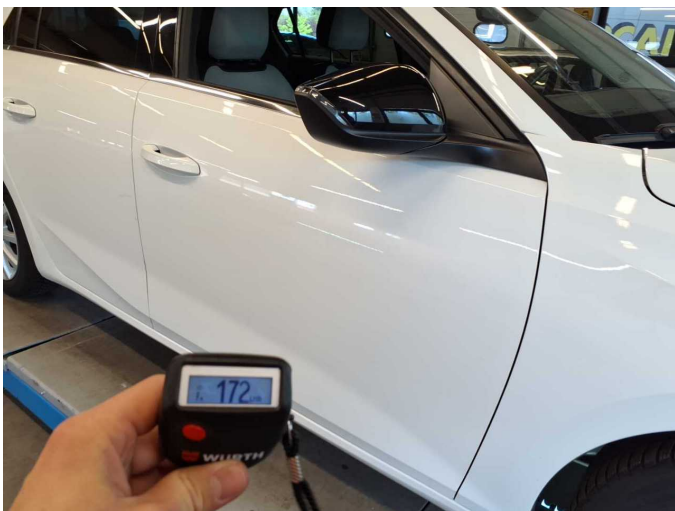
Repainting 4: Door - front right side
