Expertise

Protocol number: 46149895
Order No. / Reference: 26489486
Inspection date: 25 Jun 2026

Model: Astra 1.2 Turbo Start/Stop Sports Tourer Business Edition

VIN: W0VBD8ESXL8035274

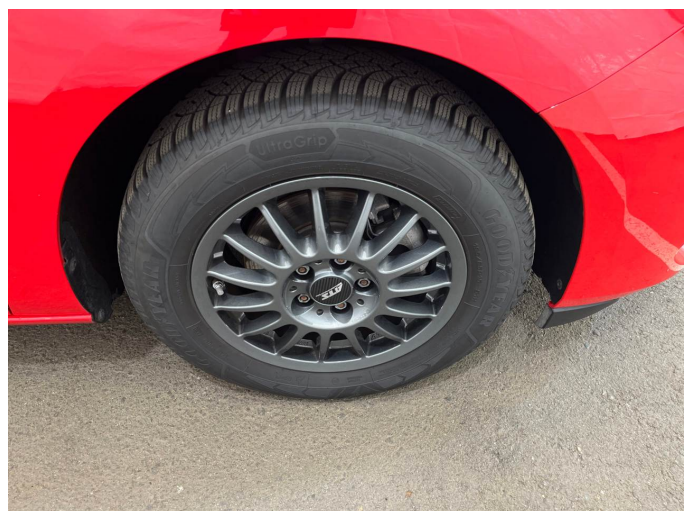
Figure 12: Mounted tyres

#	Tyre size	Type of tyre	Manufacturer	Tread depth
1)	195/65 R15 91H	Winter tyres on Light alloy	Goodyear	6mm / 6mm
2)	195/65 R15 91H	Winter tyres on Light alloy	Goodyear	7mm / 7mm
