Expertise

Protocol number: 45791402
Order No. / Reference: 26264416
Inspection date: 26 May 2026

Manufacturer: Opel

Model: Astra Sports Tourer 1.5 D Automatik Business Elegance

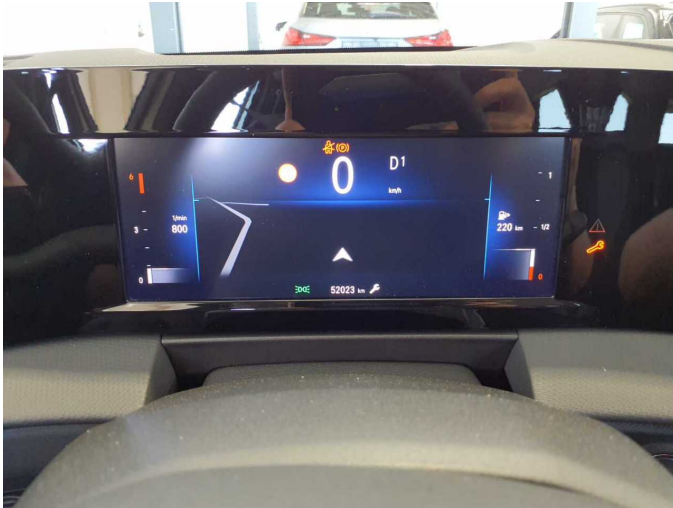
Figure 7: Instrument cluster

Restlauf Service nicht ablesbar.

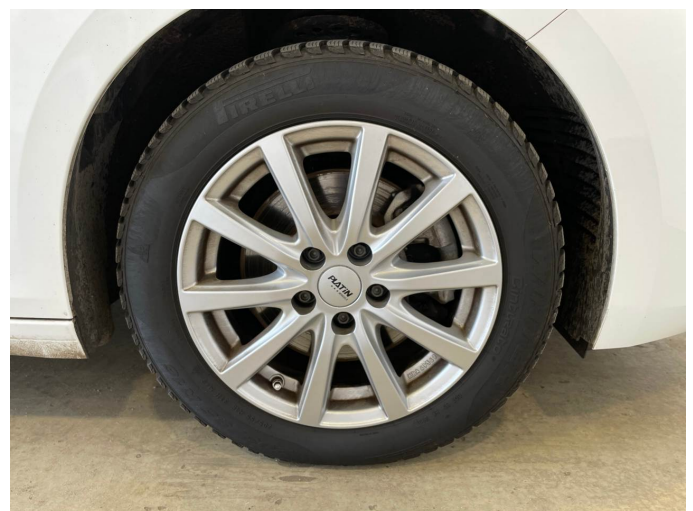
Figure 12: Mounted tyres

#	Tyre size	Type of tyre	Manufacturer	Tread depth
1)	205/55 R16 91H	Winter tyres on Light alloy	Pirelli	6mm / 6mm
2)	205/55 R16 91H	Winter tyres on Light alloy	Pirelli	7mm / 7mm

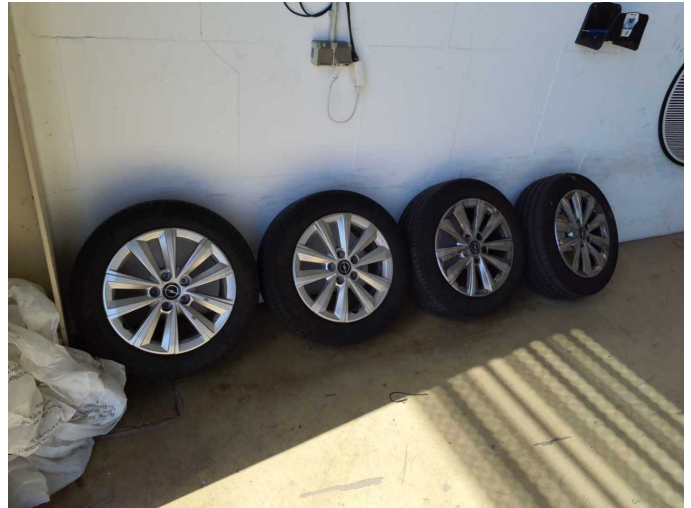
Figure 14: Additional tyres

#	Tyre size	Type of tyre	Manufacturer	Tread depth
1)	205/55 R16 94V	Summer tyres on Light alloy	Michelin	5mm / 4mm
2)	205/55 R16 94V	Summer tyres on Light alloy	Michelin	6mm / 6mm
