Expertise

Protocol number: 46844895  
Order No. / Reference: 26816532  
Inspection date: 3 Aug 2026

Manufacturer: Mercedes-Benz  
VIN: W1VVKFZ1P4281925

Model: EQV 300 lang

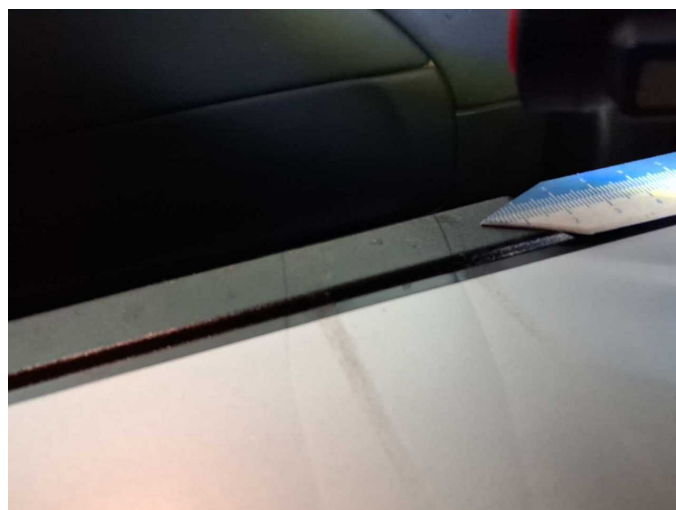
**Damage 13:** Equipment: tabletop (+ verschmutzt) - Scratched - Replace

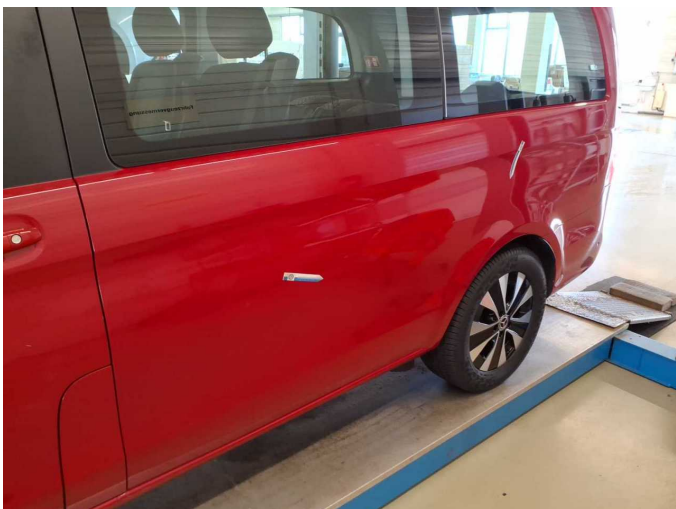
**Damage 21:** Sliding door, right: Sliding door with glass panel - dent(s) - Repair and paint
