## Expertise

Protocol number: 46243427  
Order No. / Reference: 26454023  
Inspection date: 30 Jun 2026

Model: Octavia Combi 2.0 TDI DSG 4x4 RS Plus

VIN: TMBLK0NX2PY006164

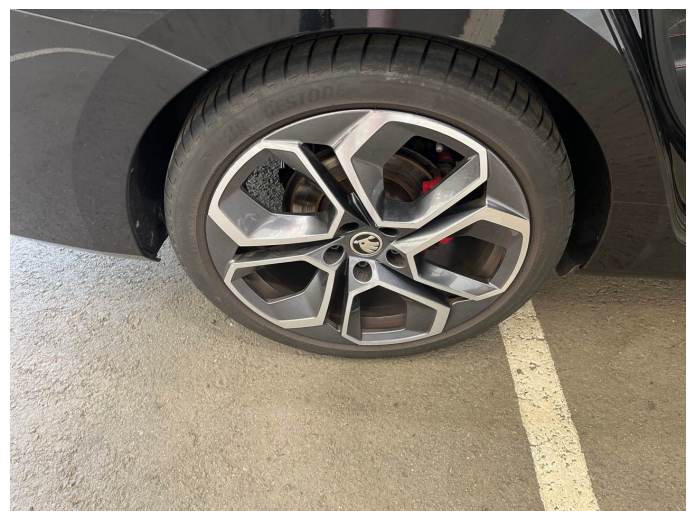
Figure 12: Mounted tyres

#	Tyre size	Type of tyre	Manufacturer	Tread depth
1)	225/40 R19 93Y	Summer tyres on Light alloy	Bridgestone	5mm / 5mm
2)	225/40 R19 93Y	Summer tyres on Light alloy	Bridgestone	6mm / 6mm
