Expertise

Protocol number: 46060785
Order No. / Reference: 26518872-1
Inspection date: 18 Jun 2026

Manufacturer: Volkswagen

Model: Caddy Cargo 2.0 TDI BMT DSG

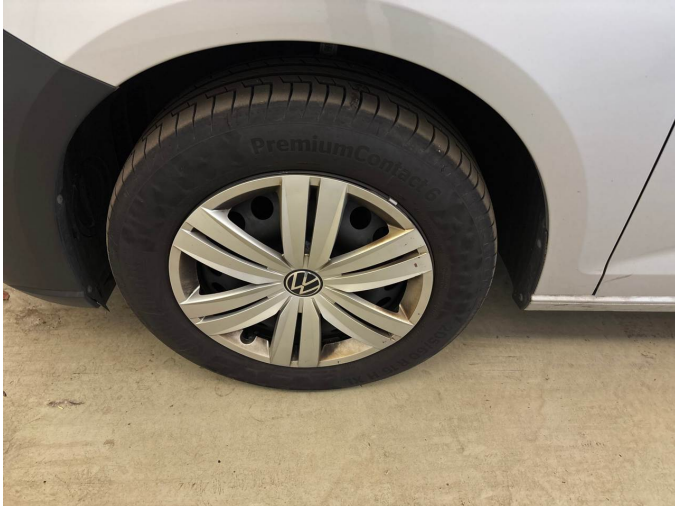
Figure 13: Mounted tyres

#	Tyre size	Type of tyre	Manufacturer	Tread depth
1)	205/60 R16 96H	Summer tyres on Steel rim with wheel cover	Continental	5mm / 5mm
2)	205/60 R16 96H	Summer tyres on Steel rim with wheel cover	Hankook	5mm / 5mm

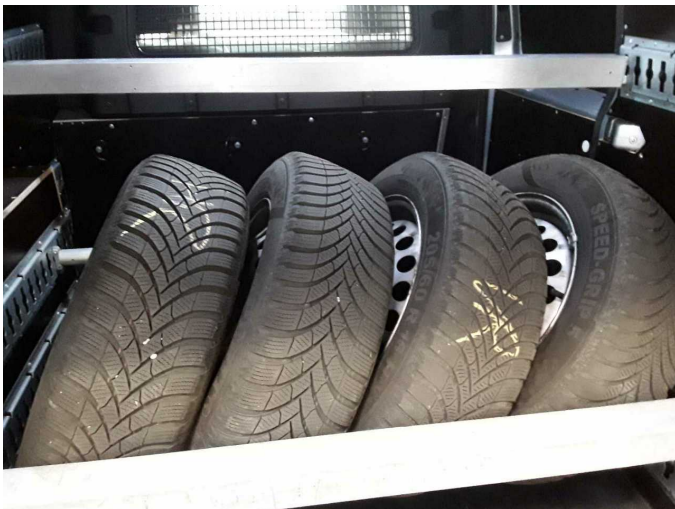
Figure 15: Additional tyres

#	Tyre size	Type of tyre	Manufacturer	Tread depth
1)	205/60 R16 96H	Winter tyres on Steel	Bridgestone	3mm / 3mm
2)	205/60 R16 96H	Winter tyres on Steel	Bridgestone	6mm / 6mm
