Expertise

Protocol number: 46722934  
Order No. / Reference: 26679519  
Inspection date: 21 Jul 2026

Manufacturer: Ford

Model: Transit Connect 250 L2 Trend

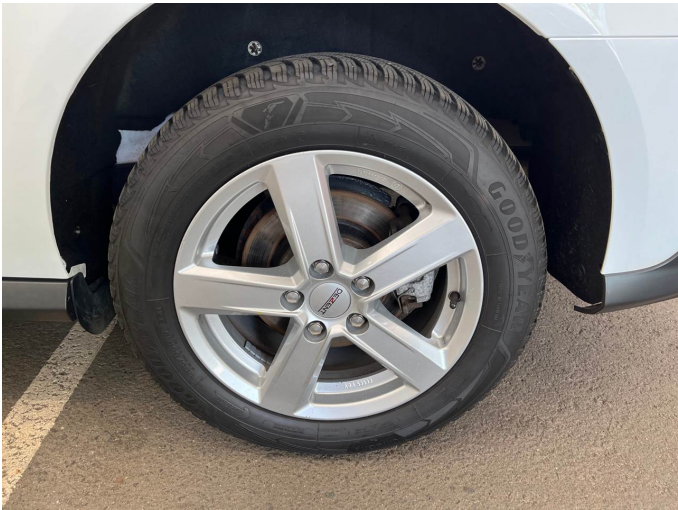
Figure 12: Mounted tyres

- Der montierte Radsatz ist gleichwertig.
- Ein Nachweis über die Zulässigkeit des montierten Radsatzes wurde nicht erbracht.
