Expertise

Protocol number: 45933099
Order No. / Reference: 26466347
Inspection date: 10 Jun 2026

Model: Kodiaq 2.0 TDI 4x4 DSG Tour

VIN: TMBLJ7NS4P8043605

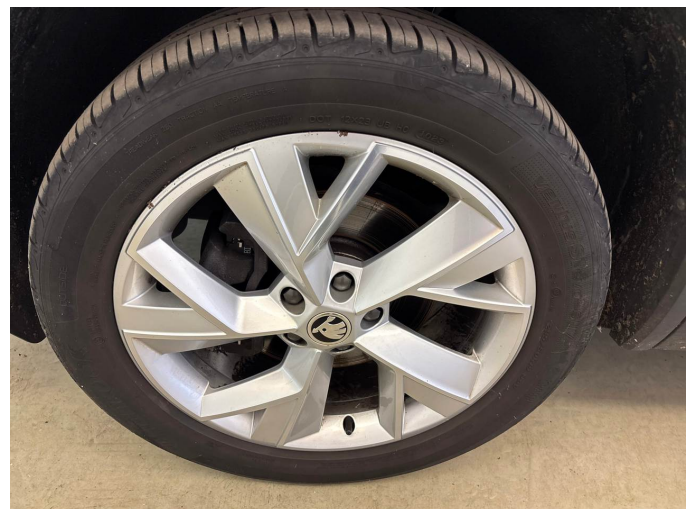
Figure 12: Mounted tyres

#	Tyre size	Type of tyre	Manufacturer	Tread depth
1)	235/50 R19 99V	Summer tyres on Light alloy	Hankook	6mm / 6mm
2)	235/50 R19 99V	Summer tyres on Light alloy	Hankook	4mm / 4mm

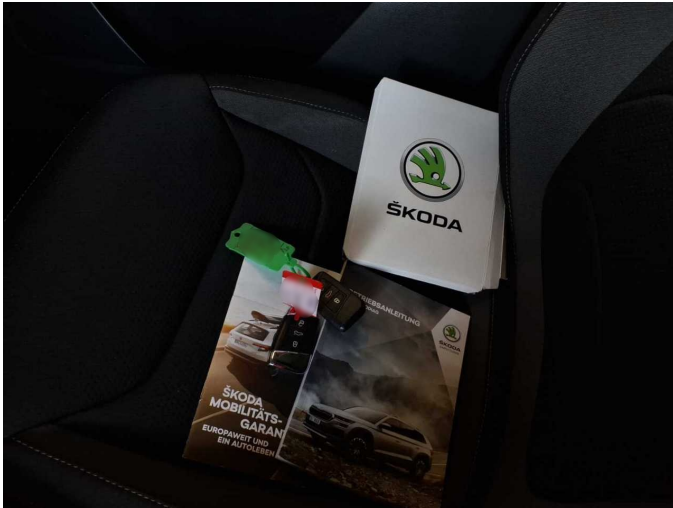
Figure 13: Documents

Documents submitted	At the time of the inspection, the vehicle registration certificate Part 2 (title) was available, but the vehicle registration certificate Part 1 (document) was not. (Copy)
VIN comparison	The vehicle identification number (VIN) was read from the vehicle and its conformity with the submitted documents was confirmed by the undersigned during the inspection.
Inspection	The inspection conditions were sufficient for the assessment of the vehicle. Lifting equipment and/or a pit were available for examining the vehicle.
Test drive	No test drive/shunting maneuver was carried out during the inspection of the vehicle.
Engine function test	An engine test run was performed.
