Expertise

Protocol number: 46576527  
Order No. / Reference: 26751535  
Inspection date: 15 Jul 2026

Model: Transit Custom 320 L1H1 LKW VA Trend

VIN: WF0YXXTTGYMC77629

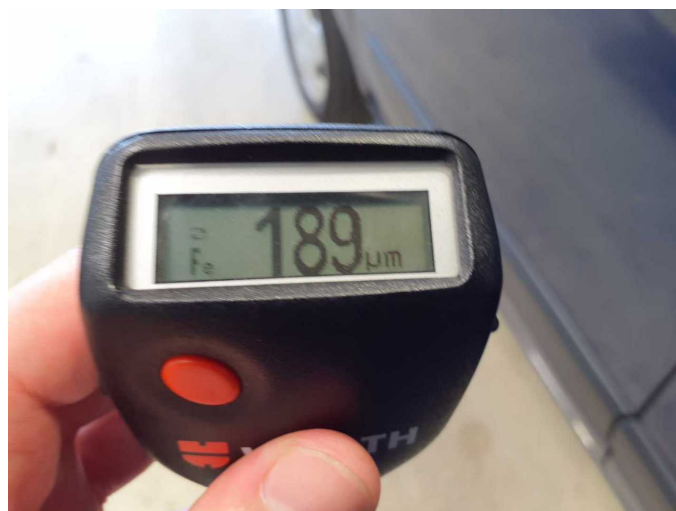
**Repainting 2:** Door - rear right side

| 2 | Door - rear right side, Unprofessionally carried out, Invoice of repair done Non-existent |
