Expertise

Protocol number: 46344291
Order No. / Reference: 26042884
Inspection date: 30 Jun 2026

Model: Vito 116 CDI Extralang HA Aut. PRO

VIN: W1VVLCEZ9T4563642

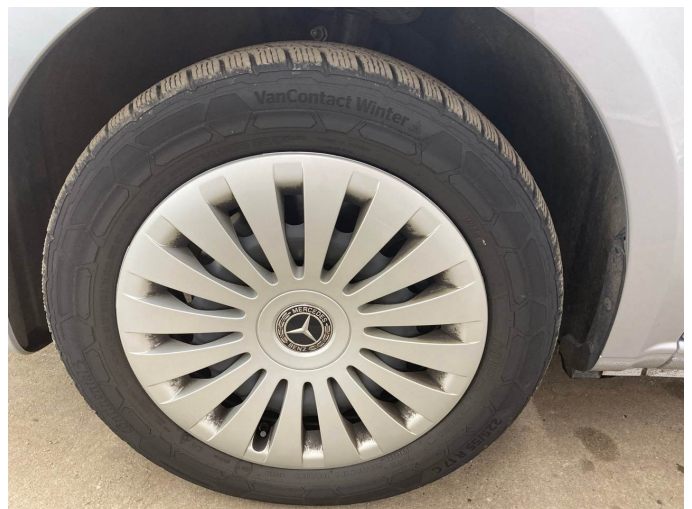
Figure 12: Mounted tyres

#	Tyre size	Type of tyre	Manufacturer	Tread depth
1)	225/55 R17 109T	Winter tyres on Steel rim with wheel cover	Continental	6mm / 6mm
2)	225/55 R17 109T	Winter tyres on Steel rim with wheel cover	Continental	5mm / 5mm
