## Expertise

Protocol number: 46250456  
Order No. / Reference: 26453339  
Inspection date: 30 Jun 2026

Model: Vito 114 CDI Kompakt HA Aut. BASE

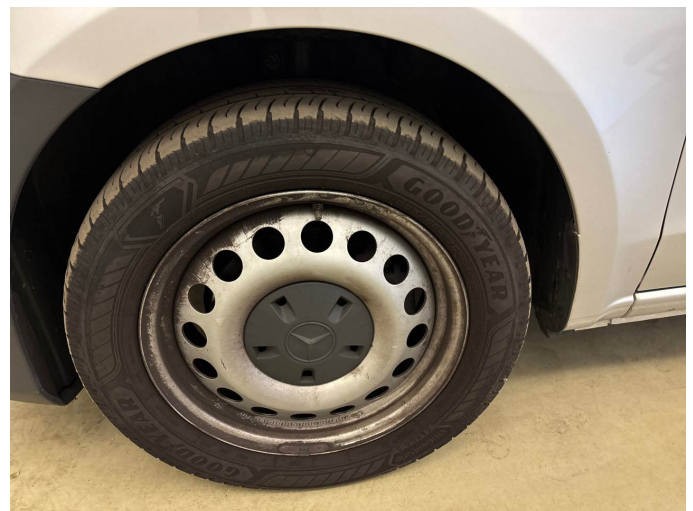
Figure 12: Mounted tyres

#	Tyre size	Type of tyre	Manufacturer	Tread depth
1)	225/55 R17 107H	Summer tyres on Steel	Goodyear	4mm / 4mm
2)	225/55 R17 107H	Summer tyres on Steel	Goodyear	4mm / 4mm

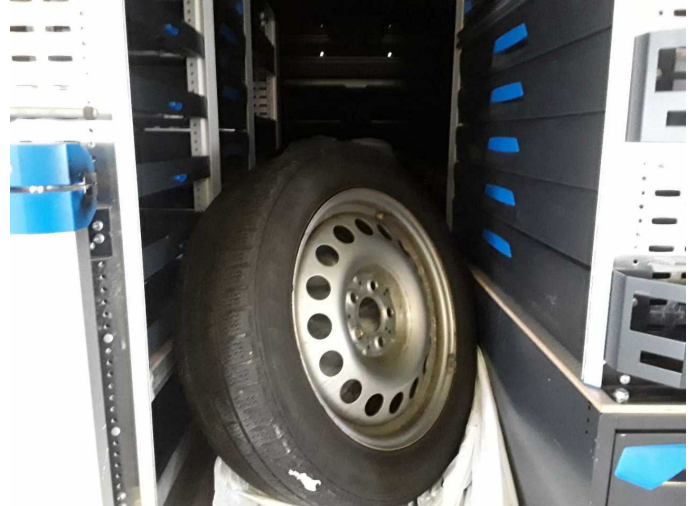
Figure 14: Additional tyres

#	Tyre size	Type of tyre	Manufacturer	Tread depth
1)	225/55 R17 107T	Winter tyres on Steel	Pirelli	5mm / 5mm
2)	225/55 R17 107T	Winter tyres on Steel	Pirelli	5mm / 5mm
