## Expertise

Protocol number: 46237484  
Order No. / Reference: 26529837  
Inspection date: 29 Jun 2026

Model: Tiguan Allspace 2.0 TDI SCR DSG Life

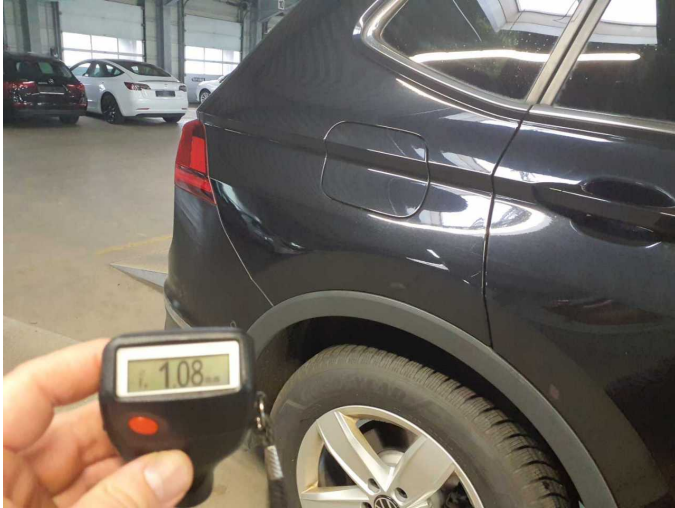
**Repainting 2:** Side panel - rear right side
