Expertise

Protocol number: 45487502
Order No. / Reference: 26284126
Inspection date: 15 May 2026

Model: Caddy Cargo 2.0 TDI BMT

VIN: WV1ZZZSKZNX031554

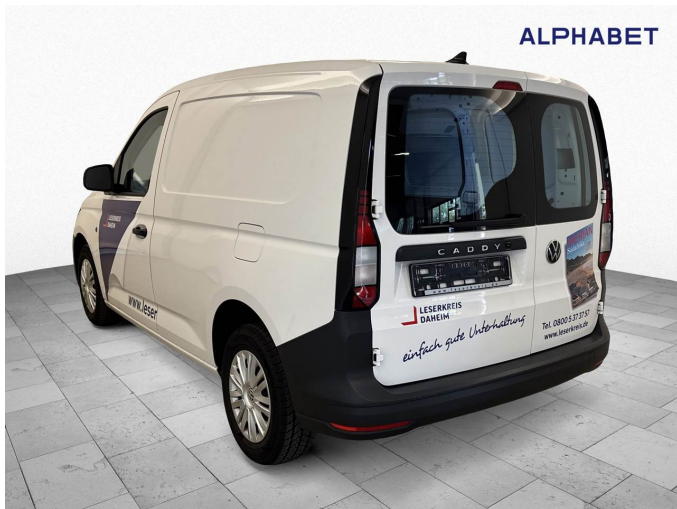
Figure 3: Diagonal rear (left)

No.	Repainting
1	Side panel - rear left side, Professionally carried out, Invoice of repair done Non-existent

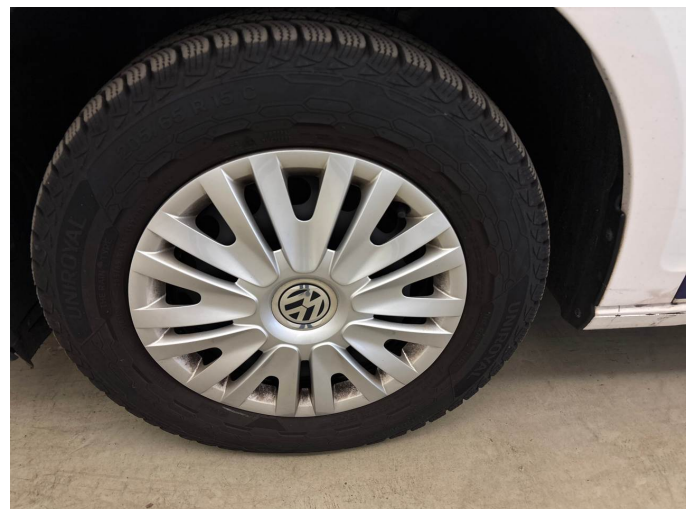
Figure 12: Mounted tyres

Mounted tyres			
#	Tyre size	Type of tyre	Tread depth
1)	205/65 R15 100T	All-season tyres on Steel rim with wheel cover	5mm / 5mm
2)	205/65 R15 100T	All-season tyres on Steel rim with wheel cover	5mm / 5mm

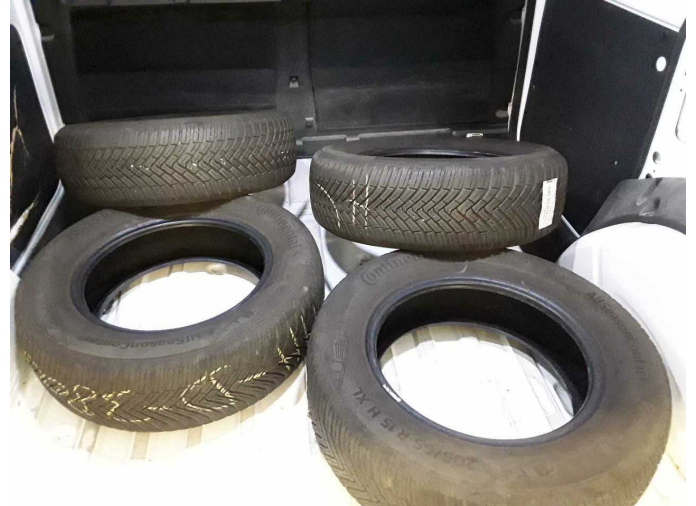
Figure 14: Additional tyres

Additional tyres			
#	Tyre size	Type of tyre	Tread depth
1)	205/65 R15 99H	All-season tyres (Without wheel rim)	5mm / 5mm
2)	205/65 R15 99H	All-season tyres (Without wheel rim)	5mm / 5mm
