Expertise

Protocol number: 45524925
Order No. / Reference: 26380221
Inspection date: 11 May 2026

Model: Kodiaq 2.0 TDI 4x4 DSG Sportline

VIN: TMBLN9NSXN8008144

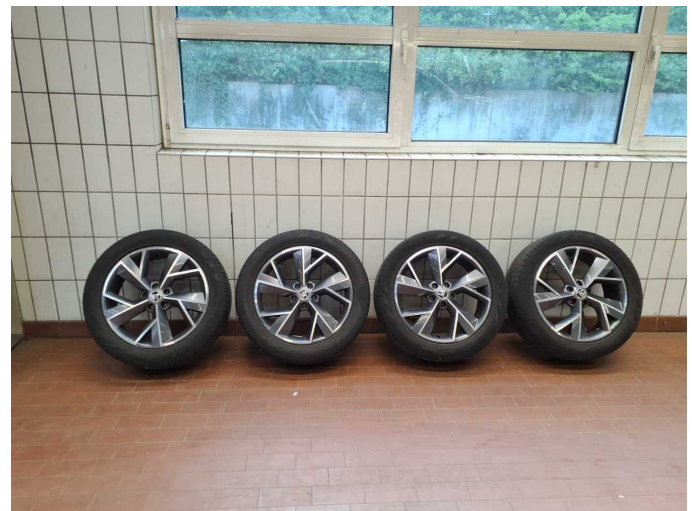
- Für den montierten Radsatz wurde kein Nachweis erbracht.
- Winterradsatz ist kein Bestandteil des Auslieferungsumfanges.

Figure 16: Additional tyres
