Expertise

Protocol number: 46363508
Order No. / Reference: 26505209
Inspection date: 6 Jul 2026

Manufacturer: Volkswagen

Model: Multivan 2,0 TDI SCR KÜ Life

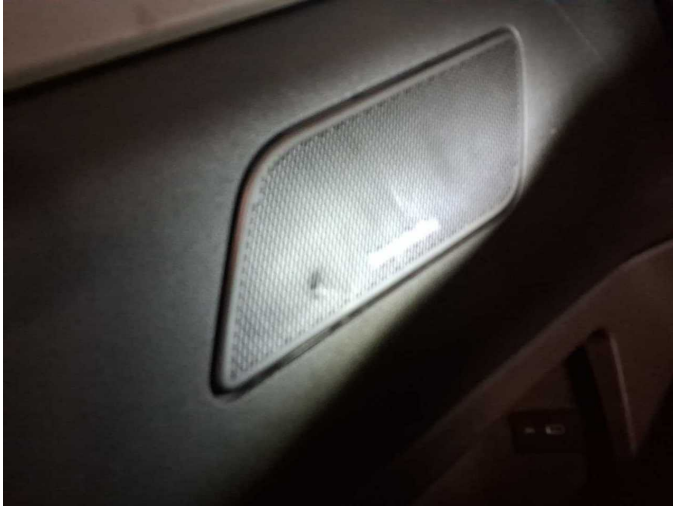
Damage 11: Door - rear left side: Speaker cover - Deformed - Loss in value

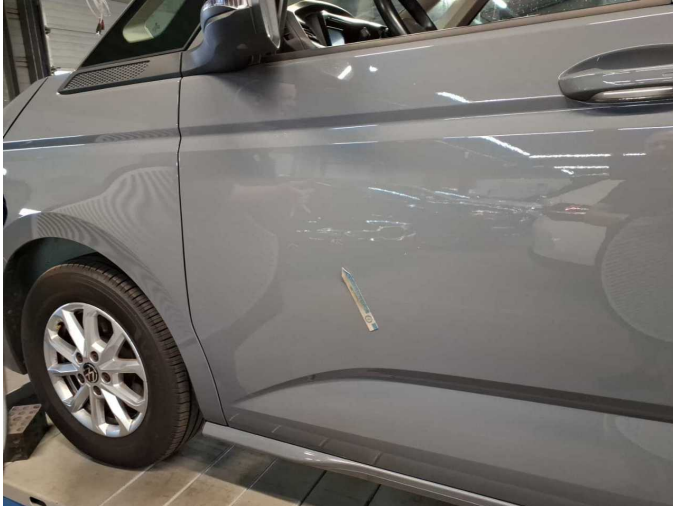
Damage 18: Door - front left side: Door - Dent / paintcoat damage - Repair and paint
