Expertise

Protocol number: 44498411
Order number / reference: 26093325
Inspection date: 16 Mar 2026

Manufacturer: Opel

Model: Movano 2.3 D L2H2 2WD VA S&S

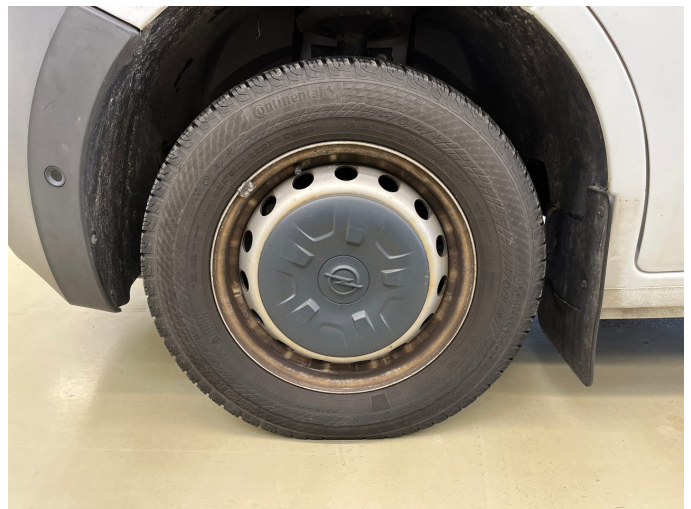
Figure 12: Mounted tyres

#	Tyre size	Type of tyre	Manufacturer	Tread depth
1)	225/65 R16 112T	All-season tyres on Steel rim with wheel cover	Continental	4mm / 4mm
2)	225/65 R16 112T	All-season tyres on Steel rim with wheel cover	Continental	5mm / 5mm
