Expertise

Protocol number: 45306790
Order No. / Reference: 26292688
Inspection date: 4 May 2026

Model: 317 CDI Sprinter Standard HA 9G-TRONIC PRO

VIN: W1V3KBFZ1TP862043

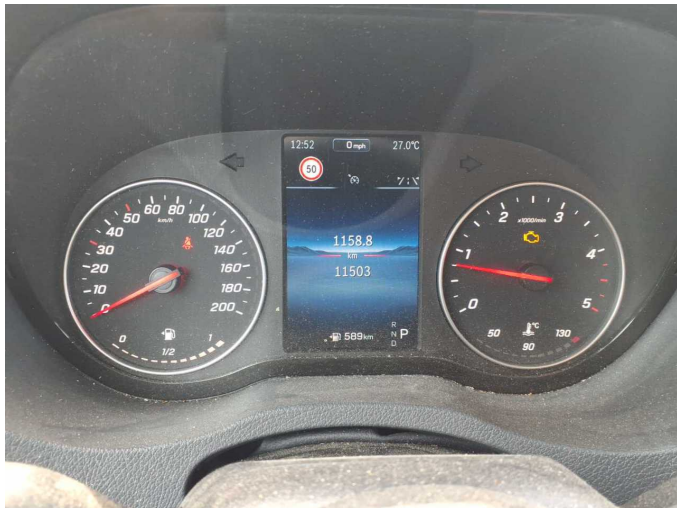
Figure 7: Instrument cluster

No.	Component group	Description
1	Instrument panel	Indicator light (Motorkontrollleuchte) - on - Perform diagnosis
2	Boot lid / rear door	Rear door - right side - Dent / paintcoat damage - Paint

Damage 1: Instrument panel: Indicator light (Motorkontrollleuchte) - on - Perform diagnosis
