Expertise

Protocol number: 46373607  
Order No. / Reference: 26445539  
Inspection date: 7 Jul 2026

Manufacturer: Ford

Model: S-Max 2.0 EcoBlue Aut. TITANIUM

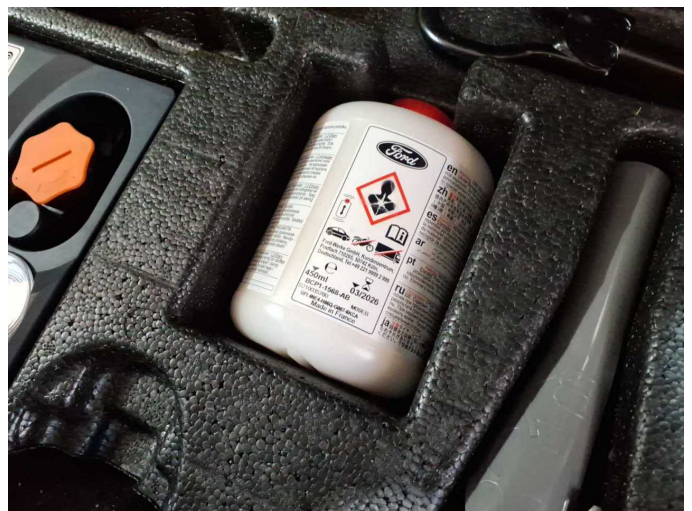
Damage 3: Equipment: Tirefit filler - Expired - Replace

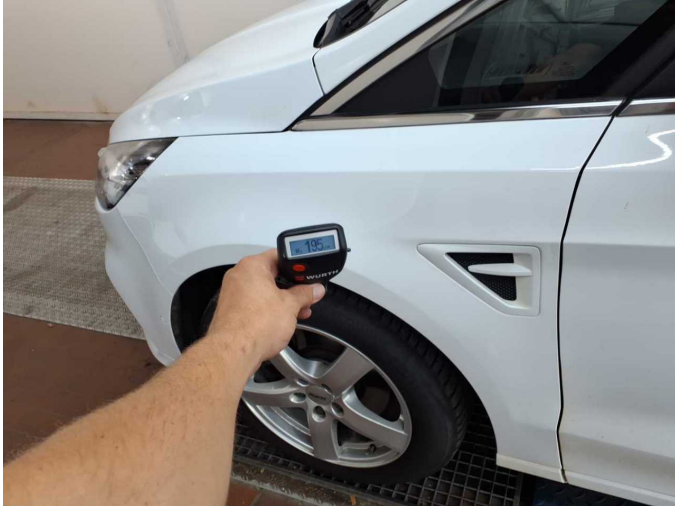
1 Boot lid / rear door, Mudguard - left side, Mudguard - right side, Bonnet, Professionally carried out, Invoice of repair done Non-existent

**Repainting 1:** Boot lid / rear door, Mudguard - left side, Mudguard - right side, Bonnet
