Expertise

Protocol number: 46481991  
Order No. / Reference: 26215332  
Inspection date: 10 Jul 2026

Manufacturer: Mercedes-Benz  
VIN: W1VVLBEZ9T4545118

Model: Vito 116 CDI Lang HA Aut. PRO

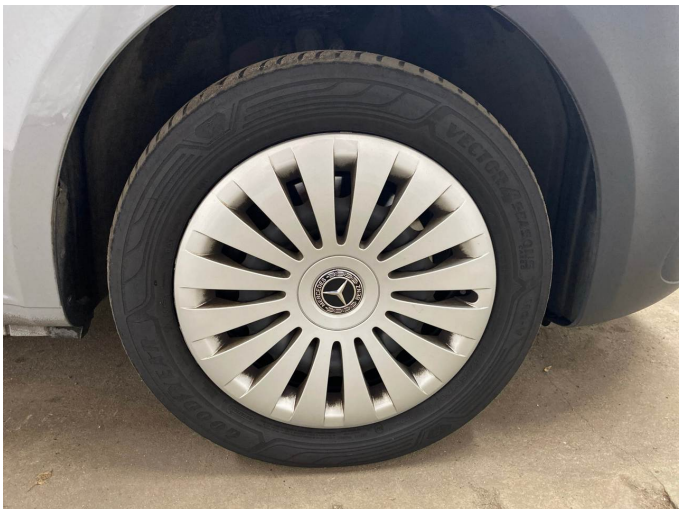
Figure 12: Mounted tyres

| No. | Component group | Description |
|---|---|---|
| 3 | Wheel / tyres | Tyre - front - does not meet manufacturer specifications - Replace |

**Damage 3:** Wheel / tyres: Tyre - front - does not meet manufacturer specifications - Replace
