Expertise

Protocol number: 45982891
Order No. / Reference: 26494513
Inspection date: 11 Jun 2026

Manufacturer: Ford

Model: S-Max 2.5 Duratec FHEV TITANIUM

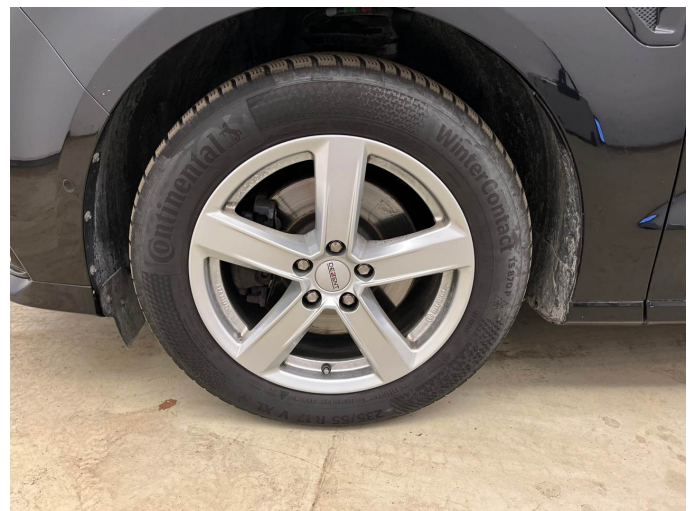
Figure 12: Mounted tyres

Mounted tyres				
#	Tyre size	Type of tyre	Manufacturer	Tread depth
1)	235/55 R17 103V	Winter tyres on Light alloy	Continental	4mm / 4mm
2)	235/55 R17 103V	Winter tyres on Light alloy	Continental	6mm / 6mm
Additional tyres				
#	Tyre size	Type of tyre	Manufacturer	Tread depth
1)	235/55 R17 103V	Summer tyres on Light alloy	Uniroyal	4mm / 4mm
2)	235/55 R17 103V	Summer tyres on Light alloy	Uniroyal	4mm / 4mm
Replacement				
Typ	Tyre size	Type of tyre	Manufacturer	Tread depth
	Tirefit	Expiration date 03/2027

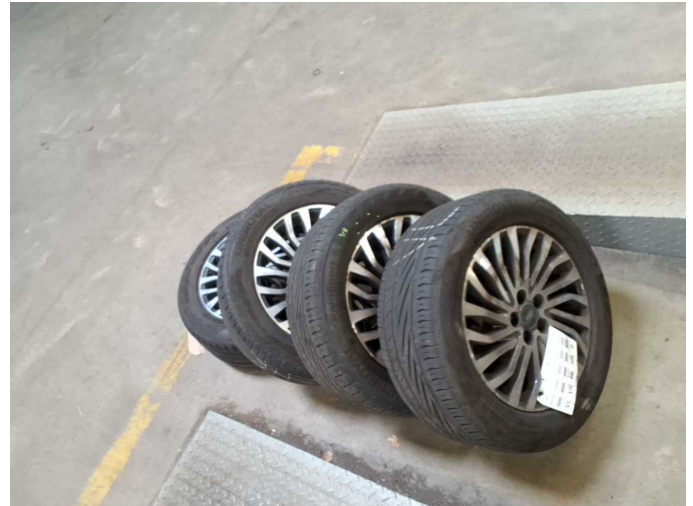
Figure 20: Additional tyres

Damage 5: 2nd wheel set: 1 tyre (Flanke) - Damaged - Replace
