Expertise

Protocol number: 46346892  
Order No. / Reference: 26638320  
Inspection date: 2 Jul 2026

Manufacturer: Volkswagen

Model: Tiguan Allspace 2.0 TDI SCR DSG Life

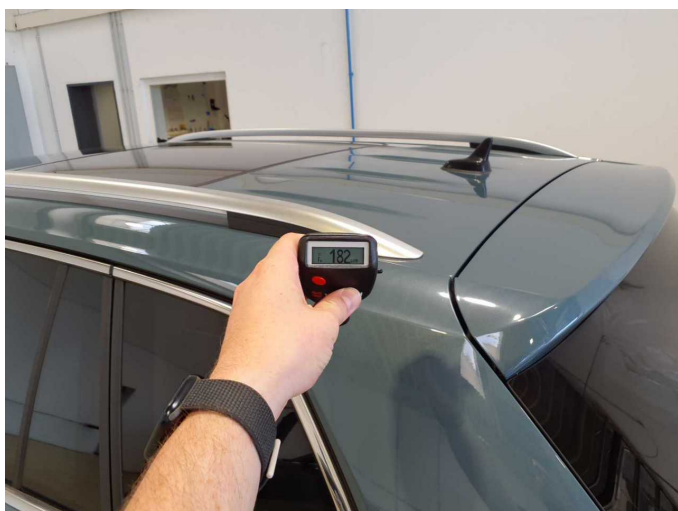
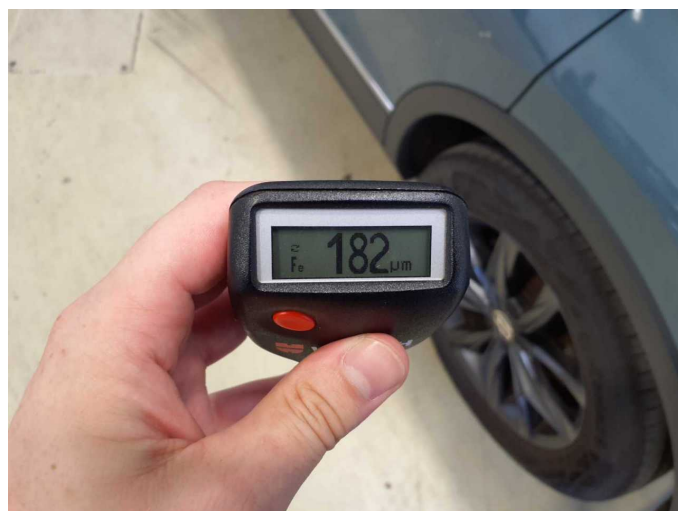
| No. | Repainting |
|---|---|
| 1 | Roof rail - left side, Professionally carried out, Invoice of repair done Non-existent |

**Repainting 1:** Roof rail - left side

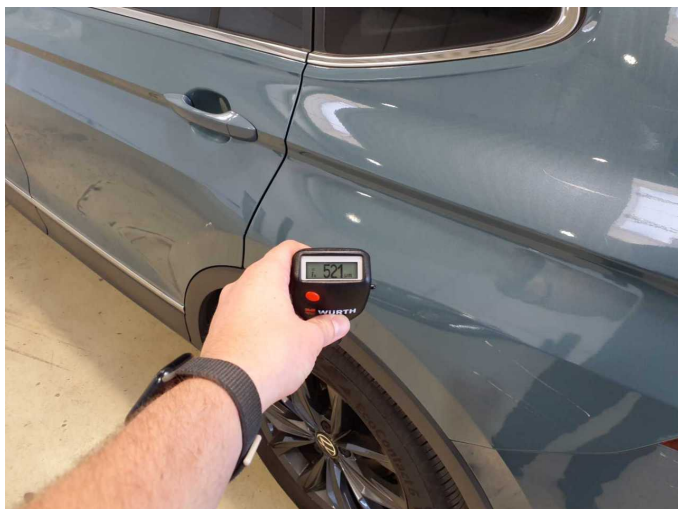
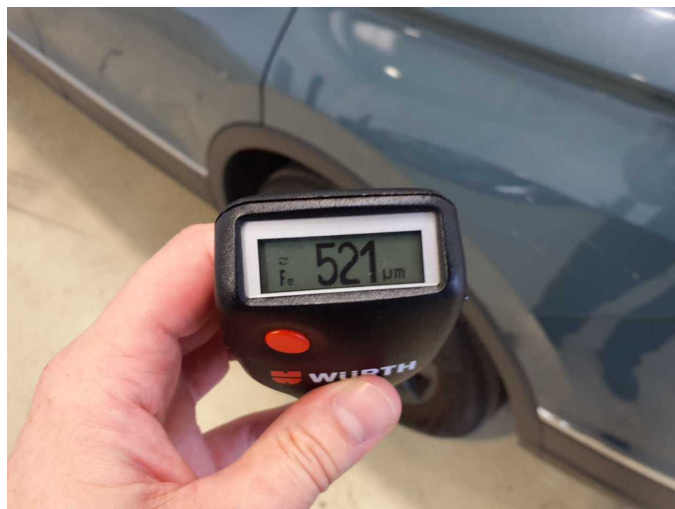
| No. | Repainting |
|---|---|
| 2 | Side panel - rear left side, Professionally carried out, Invoice of repair done Non-existent |

**Repainting 2:** Side panel - rear left side

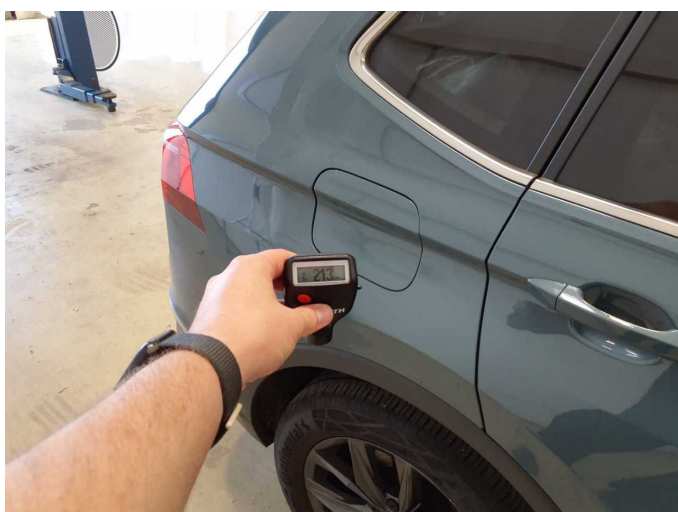
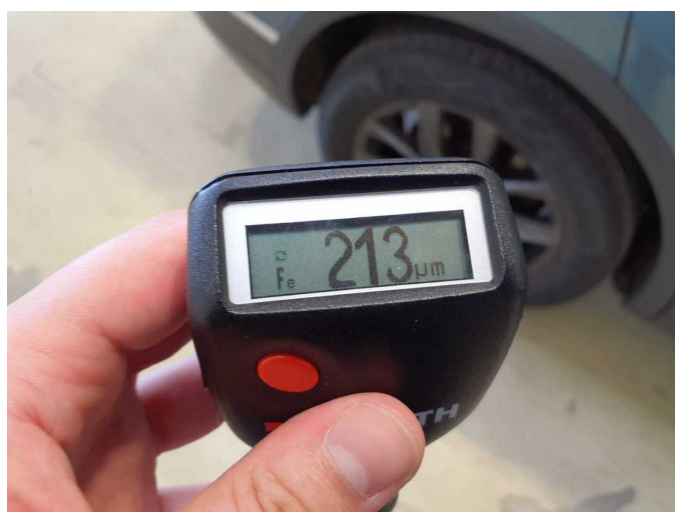
| No. | Repainting |
|---|---|
| 3 | Side panel - rear right side, Professionally carried out, Invoice of repair done Non-existent |

**Repainting 3:** Side panel - rear right side

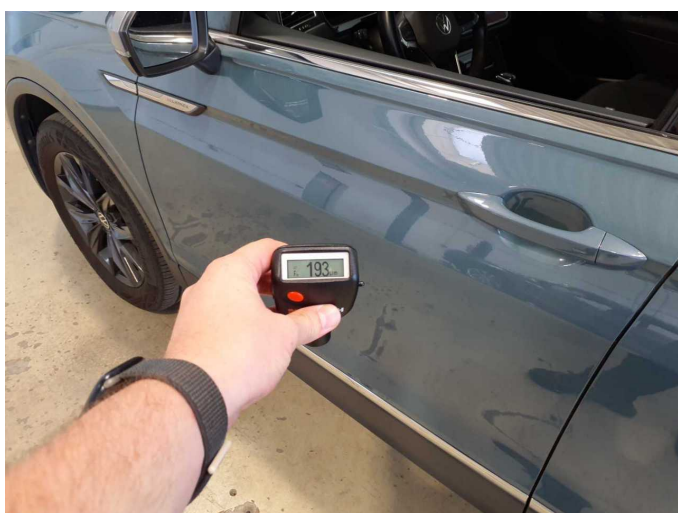
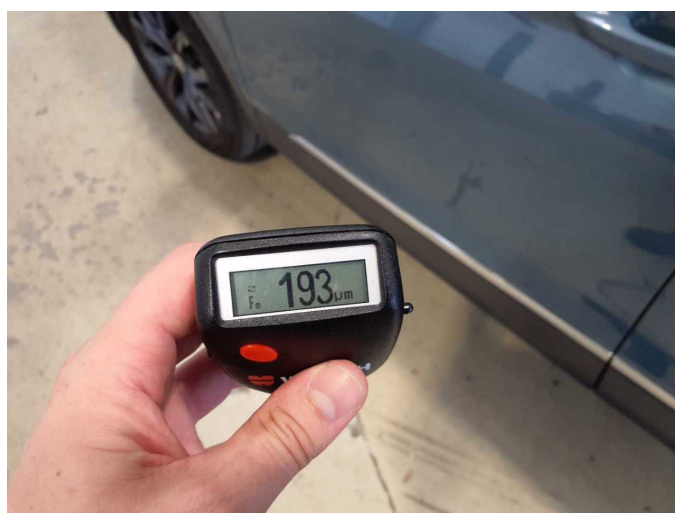
| No. | Repainting |
|---|---|
| 4 | Door - front left side, Professionally carried out, Invoice of repair done Non-existent |

**Repainting 4:** Door - front left side

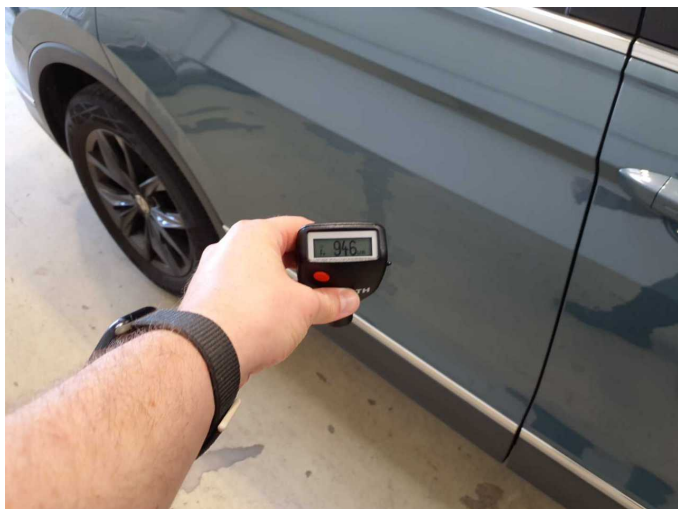
**Repainting 5:** Door - rear right side

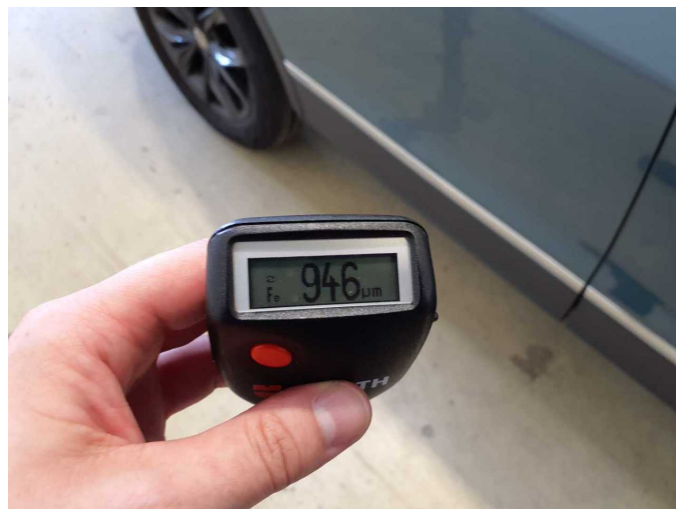
**Repainting 5:** Door - rear right side
