Expertise

Protocol number: 46466139  
Order No. / Reference: 26521300  
Inspection date: 10 Jul 2026

Manufacturer: Mercedes-Benz

Model: EQE 300 Electric Art

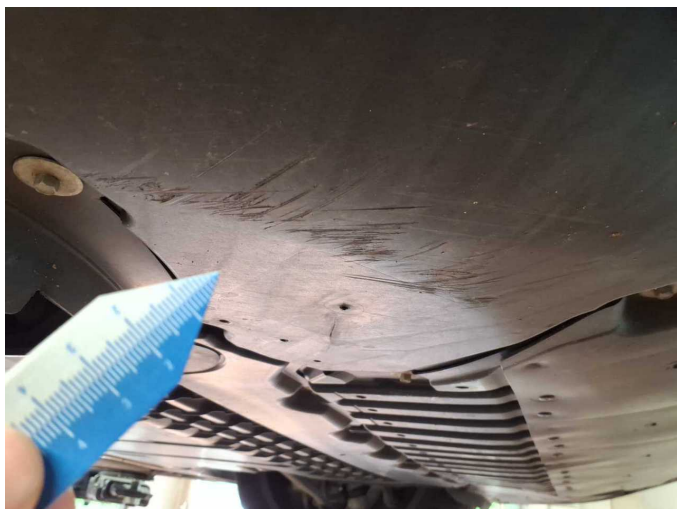
**Damage 1:** Body: Underbody panelling (Links und Rechts) - Scratched - Replace

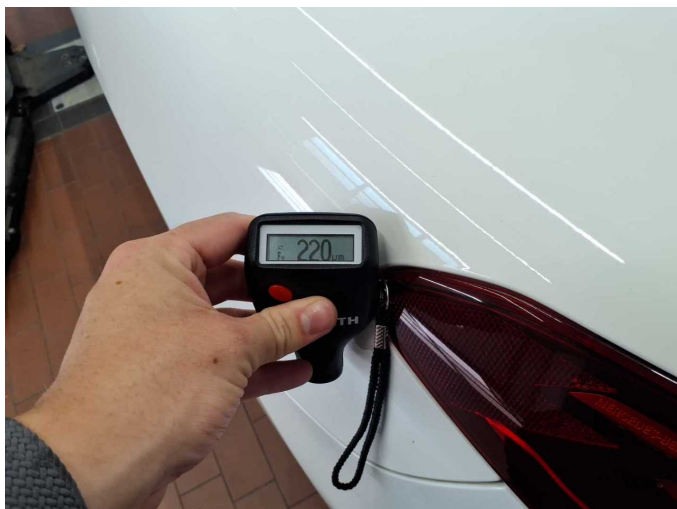
| No. | Repainting |
|---|---|
| 3 | Side panel - rear left side, Professionally carried out, Invoice of repair done Non-existent |

**Repainting 3:** Side panel - rear left side

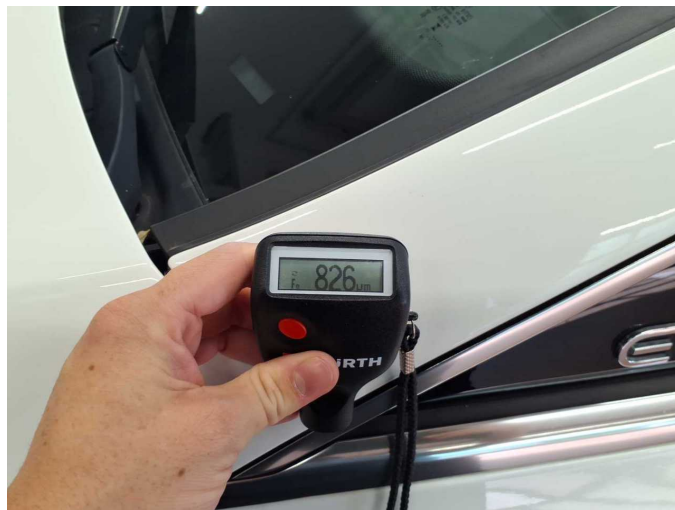
| No. | Repainting |
|---|---|
| 6 | Roof rail - left side, Unprofessionally carried out, Invoice of repair done Non-existent |

**Repainting 6:** Roof rail - left side
