Expertise

Protocol number: 43488009
Order number / reference: 25764302
Inspection date: 21 Jan 2026

Model: Kodiaq 2.0 TDI DSG Tour

VIN: TMBJJ9NS3P8024174

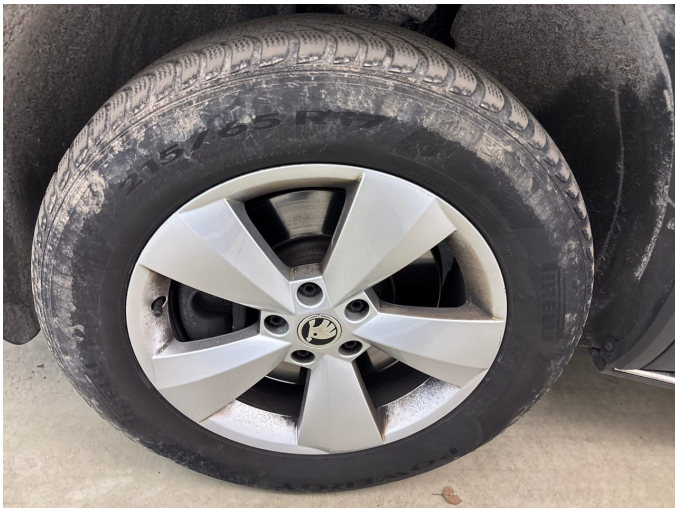
Figure 13: Mounted tyres

#	Tyre size	Type of tyre	Manufacturer	Tread depth
1)	215/65 R17 103H	Winter tyres on Light alloy	Pirelli	3mm / 3mm
2)	215/65 R17 103H	Winter tyres on Light alloy	Pirelli	6 mm
	215/65 R17 103H	All-season tyres on Light alloy	Pirelli	6 mm
