Expertise

Protocol number: 45790962
Order No. / Reference: 26153260
Inspection date: 2 Jun 2026

Manufacturer: Mercedes-Benz

Model: 317 CDI Sprinter Standard HA 9G-TRONIC PRO

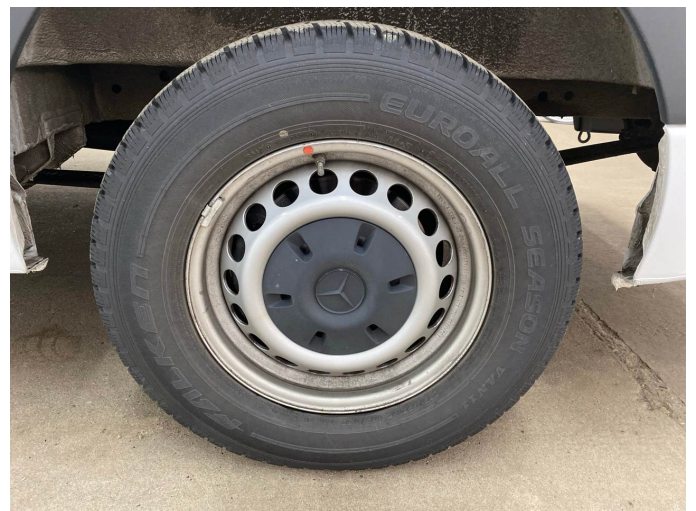
Figure 12: Mounted tyres

#	Tyre size	Type of tyre	Manufacturer	Tread depth
1)	235/65 R16 115R	All-season tyres on Steel rim with wheel cover	Falken	7mm / 7mm
2)	235/65 R16 115R	All-season tyres on Steel rim with wheel cover	Falken	6mm / 6mm

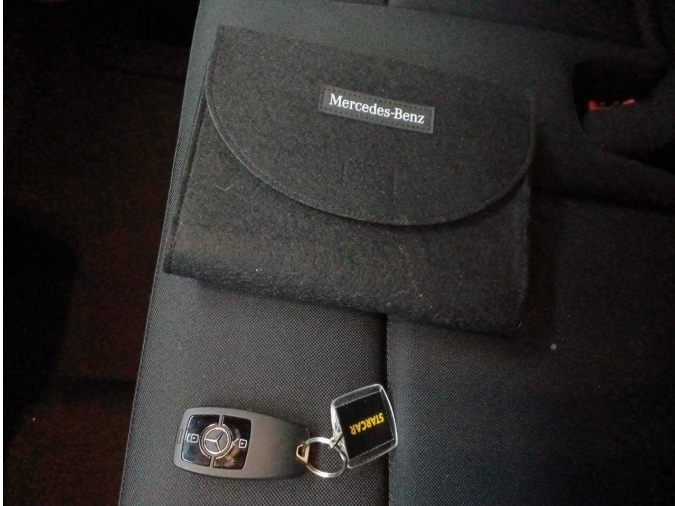
Figure 13: Documents

Documents submitted	At the time of the inspection, the vehicle registration certificate Part 2 (title) was available, but the vehicle registration certificate Part 1 (document) was not. (Copy)
VIN comparison	The vehicle identification number (VIN) was read from the vehicle and its conformity with the submitted documents was confirmed by the undersigned during the inspection.
Inspection	The inspection conditions were sufficient for the assessment of the vehicle. Lifting equipment and/or a pit were available for examining the vehicle.
Test drive	No test drive/shunting maneuver was carried out during the inspection of the vehicle.
Engine function test	An engine test run was performed.
