## Expertise

Protocol number: 45990412  
Order No. / Reference: 26451713  
Inspection date: 15 Jun 2026

Model: Vivaro 2.0 D Cargo L EHZ Autm. Elegance

VIN: VXEVFEHZ7N7039844

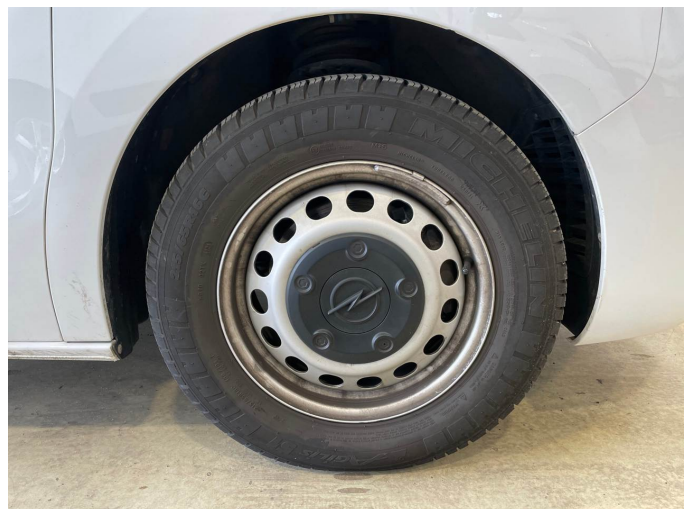
Figure 12: Mounted tyres

#	Tyre size	Type of tyre	Manufacturer	Tread depth
1)	215/65 R16 106T	Summer tyres on Steel rim with wheel cover	Michelin	5mm / 5mm
2)	215/65 R16 106T	Summer tyres on Steel rim with wheel cover	Michelin	5mm / 5mm

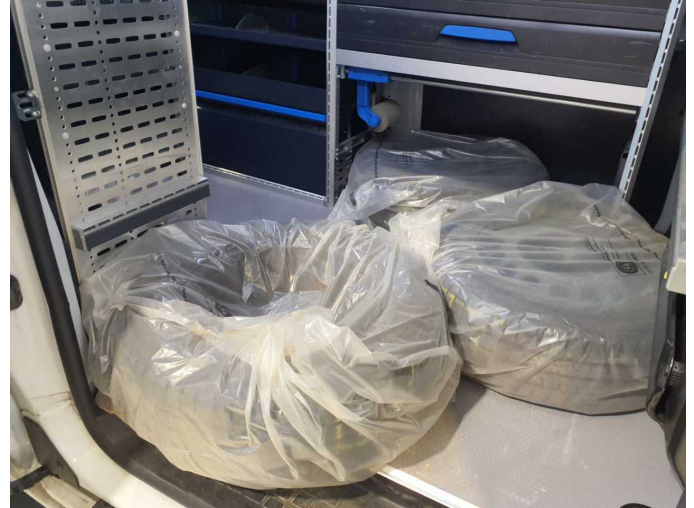
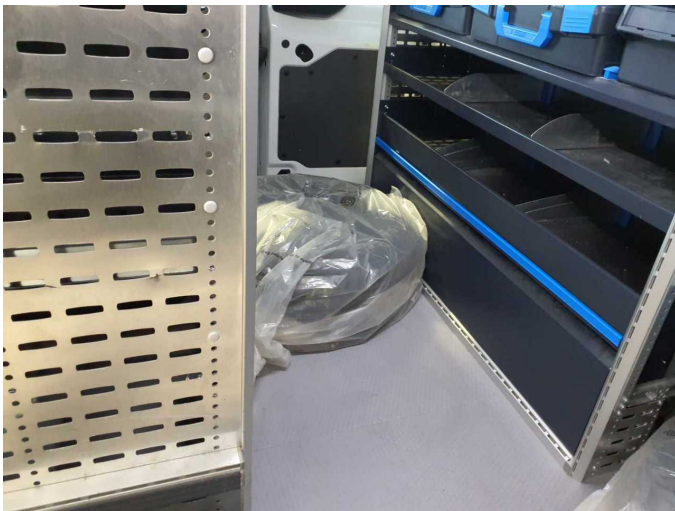
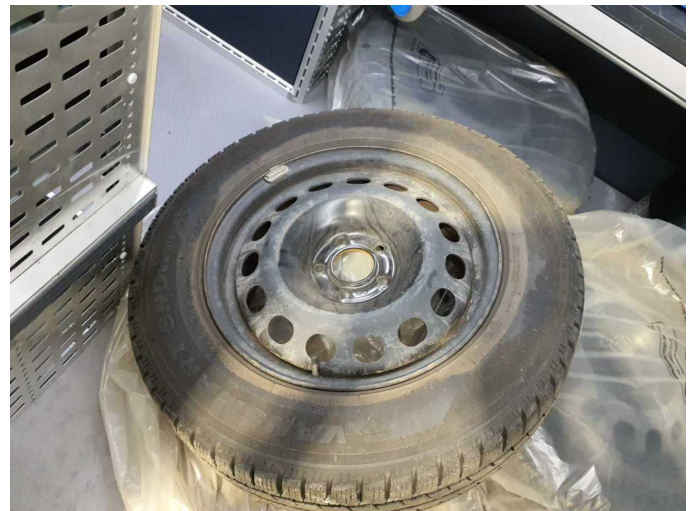
Figure 14: Additional tyres

#	Tyre size	Type of tyre	Manufacturer	Tread depth
1)	215/65 R16 109T	Winter tyres on Steel	Maxxis	6mm / 6mm
2)	215/65 R16 109T	Winter tyres on Steel	Maxxis	7mm / 7mm

Der beiliegende Winterradsatz ist kein Bestandteil der Ausstattung.
