Expertise

Protocol number: 46494078  
Order No. / Reference: 26488445  
Inspection date: 10 Jul 2026

| Manufacturer: Opel | Model: Astra 1.2 Turbo Start/Stop Sports Tourer Edition |

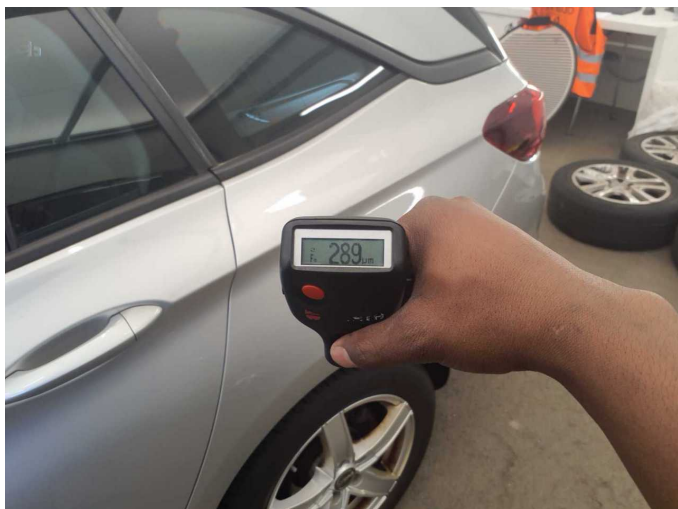
- 7 Side panel - rear left side, Professionally carried out, Invoice of repair done Non-existent
- 8 Side panel - rear right side, Professionally carried out, Invoice of repair done Non-existent

**Repainting 7:** Side panel - rear left side

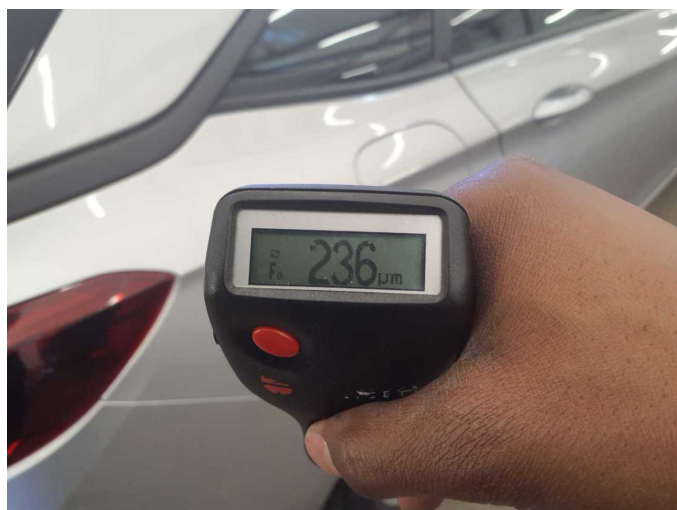
**Repainting 8:** Side panel - rear right side
