Expertise

Protocol number: 46350867
Order No. / Reference: 26042958
Inspection date: 2 Jul 2026

Model: Vito 116 CDI Extralang HA Aut. PRO

VIN: W1VVLCEZ3T4564902

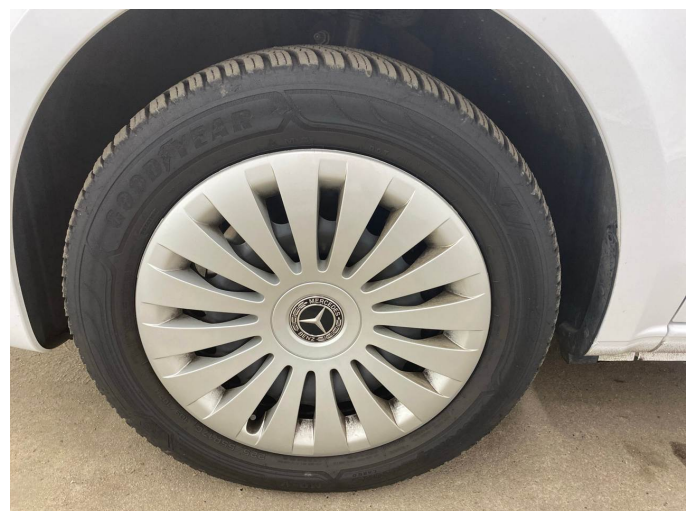
Figure 12: Mounted tyres

#	Tyre size	Type of tyre	Manufacturer	Tread depth
1)	225/55 R17 109H	All-season tyres on Steel rim with wheel cover	Goodyear	6mm / 6mm
2)	225/55 R17 109H	All-season tyres on Steel rim with wheel cover	Goodyear	6mm / 6mm
