Expertise

Protocol number: 46627503  
Order No. / Reference: 26685754  
Inspection date: 21 Jul 2026

Manufacturer: CUPRA

Model: Formentor 2.0 TDI

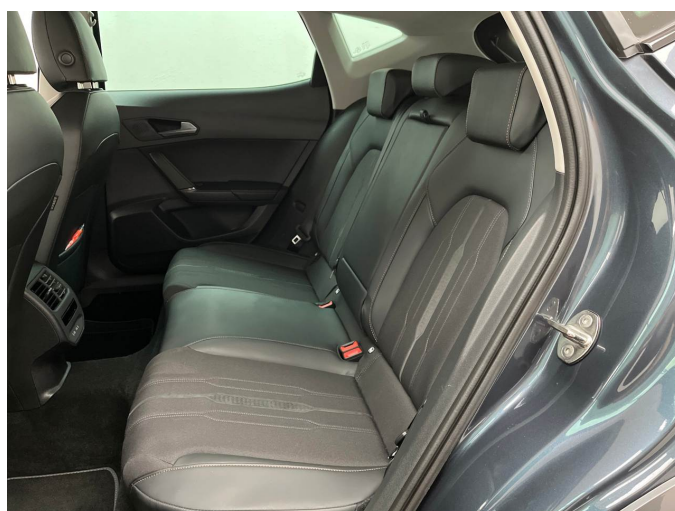
Figure 6: Interior - rear

| No. | Component group | Description |
|---|---|---|
| 2 | Seat - rear | Backrest cover - Porous / cracked - Replace |

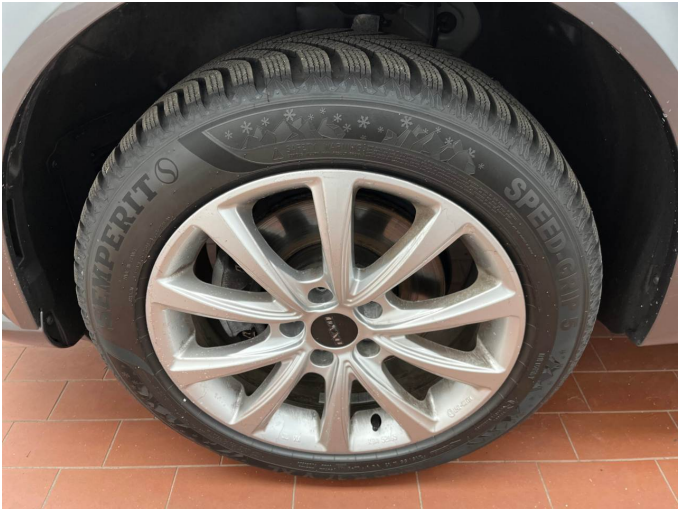
Figure 12: Mounted tyres

| # | Tyre size | Type of tyre | Manufacturer | Tread depth |
|---|---|---|---|---|
| 1) | 215/55 R17 98V | Winter tyres on Light alloy | Semperit | 8mm / 8mm |
| 2) | 215/55 R17 98V | Winter tyres on Light alloy | Semperit | 8mm / 8mm |
