Expertise

Protocol number: 46829658  
Order No. / Reference: 26566424-1  
Inspection date: 6 Jul 2026

Manufacturer: Opel

Model: Combo Life 1.2 Turbo Start/Stop Edition

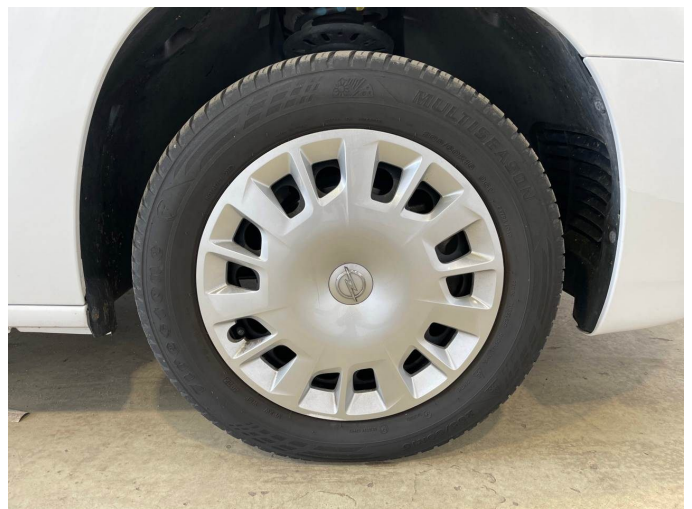
Figure 12: Mounted tyres

| # | Tyre size | Type of tyre | Manufacturer | Tread depth |
|---|---|---|---|---|
| 1) | 205/60 R16 96V | All-season tyres on Steel rim with wheel cover | Firestone | 5mm / 5mm |
| 2) | 205/60 R16 96V | All-season tyres on Steel rim with wheel cover | Firestone | 5mm / 5mm |
