Expertise

Protocol number: 46307795
Order No. / Reference: 26646088
Inspection date: 2 Jul 2026

Manufacturer: Peugeot

Model: 308 SW BlueHDi 130 EAT8 Allure

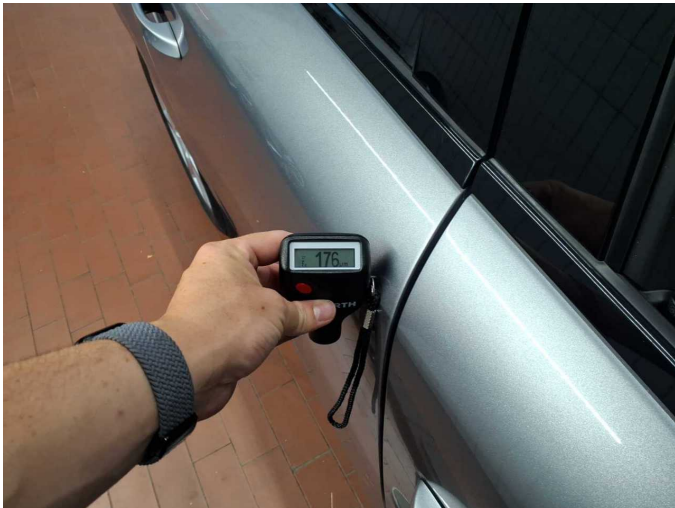
| No. | Repainting |
|---|--|
| 2 | Door - rear right side, Professionally carried out, Invoice of repair done Non-existent |

Repainting 2: Door - rear right side
