Expertise

Protocol number: 45443515
Order No. / Reference: 26430857
Inspection date: 13 May 2026

Model: Proace 2,0-I-D-4D L2 Comfort

VIN: YARVFEHTMGZ253941

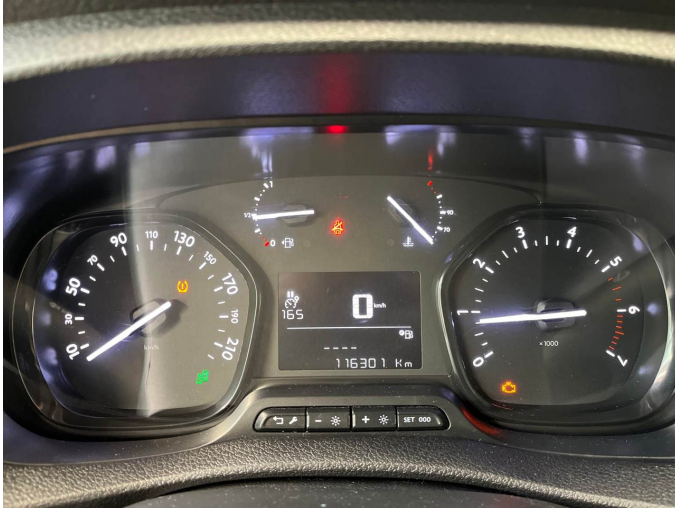
Figure 7: Instrument cluster

Documents submitted	At the time of the inspection, the vehicle registration certificate Part 2 (title) was available, but the vehicle registration certificate Part 1 (document) was not. (Copy)
VIN comparison	The vehicle identification number (VIN) was read from the vehicle and its conformity with the submitted documents was confirmed by the undersigned during the inspection.
Inspection	The inspection conditions were sufficient for the assessment of the vehicle. No lifting equipment or pit was available for inspecting the vehicle. Therefore, inspection of the vehicle's underside was only possible to a limited extent.
Test drive	A short maneuvering and shunting exercise was carried out on the company premises.
Engine function test	An engine test run was performed, problem has been detected This is due to the following reason.: Motorkontrolle aktiv
