Expertise

Protocol number: 46383769  
Order No. / Reference: 26483985  
Inspection date: 7 Jul 2026

Manufacturer: Skoda  
VIN: TMBAH7NP3N7020690

Model: Superb 2.0 TDI DSG Premium Edition

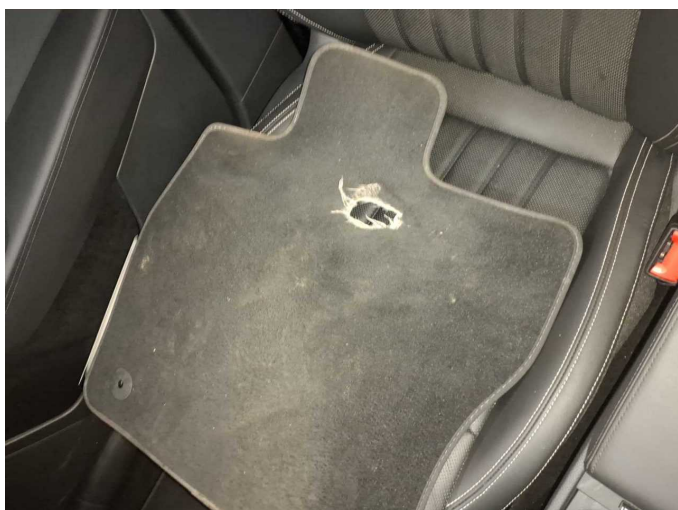
| No. | Component group | Description |
|---|---|---|
| 1 | Trim / covers | Floor mats (Fußmatte vorne Links) - Broken / torn - Replace |

**Damage 1:** Trim / covers: Floor mats (Fußmatte vorne Links) - Broken / torn - Replace

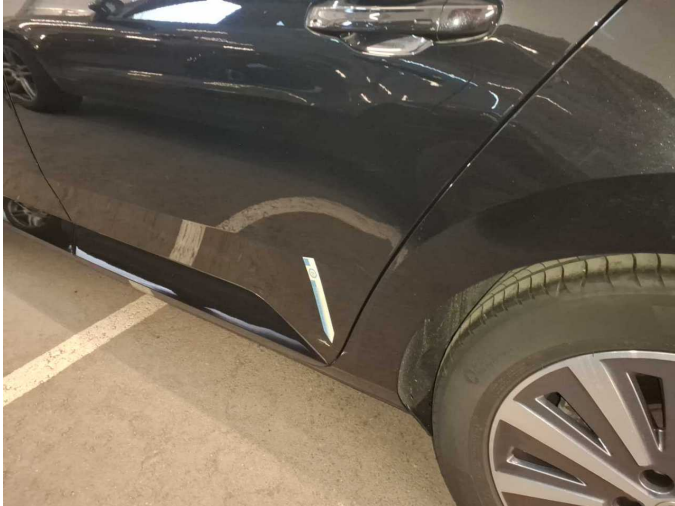
**Accident 1:** Side - left

**Accident 1: Side - left**
