Expertise

Protocol number: 45440513
Order No. / Reference: 26104880
Inspection date: 12 May 2026

Manufacturer: Opel

Model: Astra Sports Tourer 1.5 D Automatik Elegance

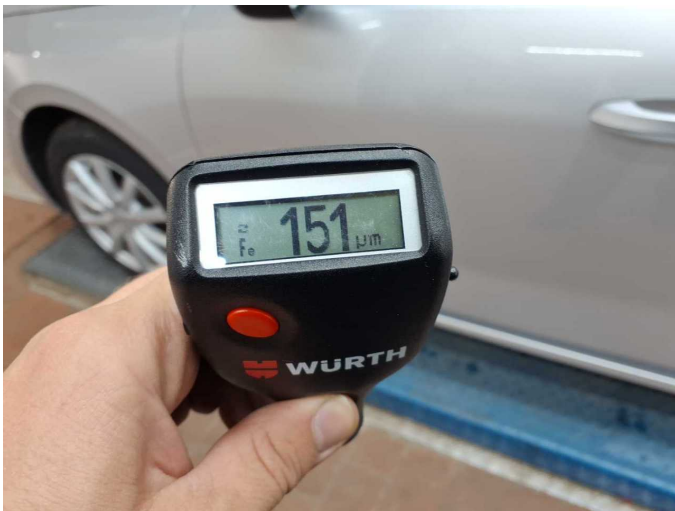
No.	Repainting
1	Side panel - rear left side, Door - rear right side, Professionally carried out, Invoice of repair done Non-existent

Repainting 1: Side panel - rear left side, Door - rear right side
