Expertise

Protocol number: 44953788
Order No. / Reference: 26234223
Inspection date: 13 Apr 2026

Manufacturer: Ford

Model: Kuga 2.0 EcoBlue 4x4 Aut. TITANIUM

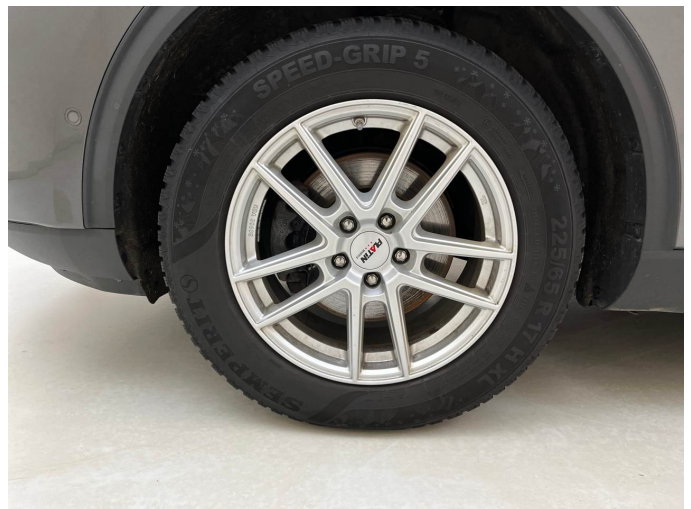
Figure 12: Mounted tyres

#	Tyre size	Type of tyre	Manufacturer	Tread depth
1)	225/65 R17 106H	Winter tyres on Light alloy	Semperit	6mm / 6mm
2)	225/65 R17 106H	Winter tyres on Light alloy	Continental	7mm / 7mm

- Für den montierten Radsatz wurde kein Nachweis erbracht.
- Winterradsatz ist kein Bestandteil des Auslieferungsumfangs.

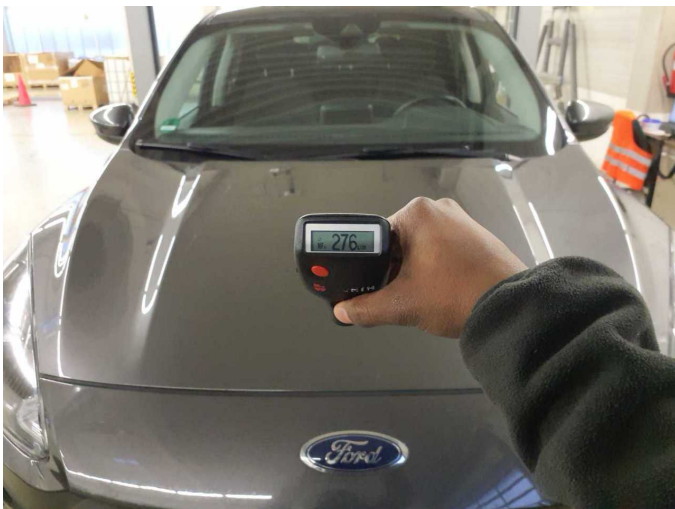
Repainting 2: Bonnet
