Expertise

Protocol number: 46850927  
Order No. / Reference: 26836657  
Inspection date: 3 Aug 2026

Manufacturer: Toyota  
VIN: YARECYHT2GJ019007

Model: Proace City Verso 1.5 D-4D L1 Shuttle

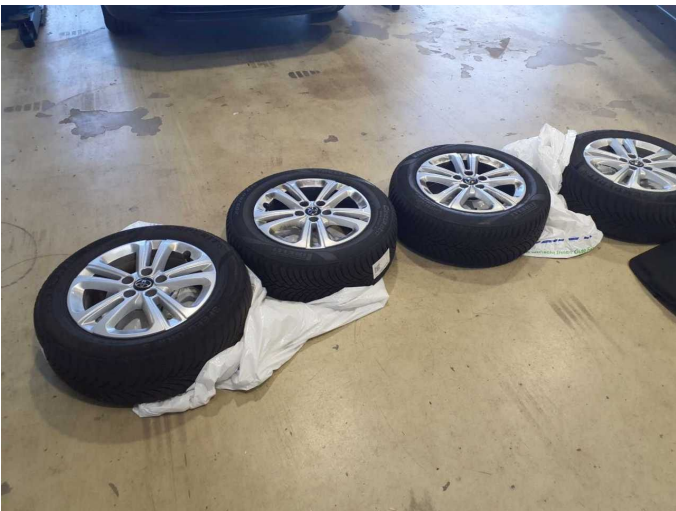
Figure 15: Additional tyres

| No. | Component group | Description |
|---|---|---|
| 6 | 2nd wheel set | 2 tyres (gehören nicht zur Ausstattung) - Worn - No deduction |
