## Expertise

Protocol number: 46280423  
Order No. / Reference: 26554200  
Inspection date: 1 Jul 2026

Model: Focus Turnier 1.5 EcoBlue Start-Stopp-System  
COOL&CONNECT

VIN: WF0PXXGCHPLS81489

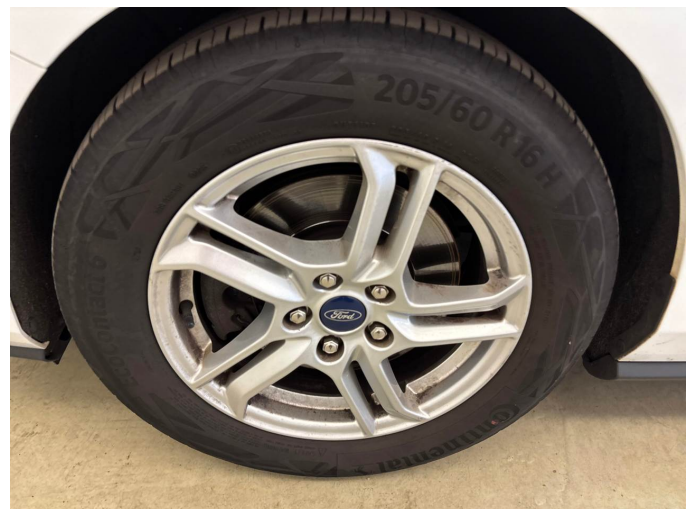
Figure 12: Mounted tyres

Mounted tyres				
#	Tyre size	Type of tyre	Manufacturer	Tread depth
1)	205/60 R16 92H	Summer tyres on Light alloy	Continental	3mm / 3mm
2)	205/60 R16 92H	Summer tyres on Light alloy	Continental	4mm / 4mm
Additional tyres				
#	Tyre size	Type of tyre	Manufacturer	Tread depth
1)	205/60 R16 96H	Winter tyres on Light alloy	Continental	5mm / 5mm
2)	205/60 R16 96H	Winter tyres on Light alloy	Continental	5mm / 5mm
Replacement				
Typ	Tyre size	Type of tyre	Manufacturer	Tread depth
	Tirefit	Expiration date 12/2024
