Expertise

Protocol number: 44529452  
Order number / reference: 26003252  
Inspection date: 17 Mar 2026

Manufacturer: Ford

Model: Mondeo Turnier 2.0 EcoBlue Aut. Titanium

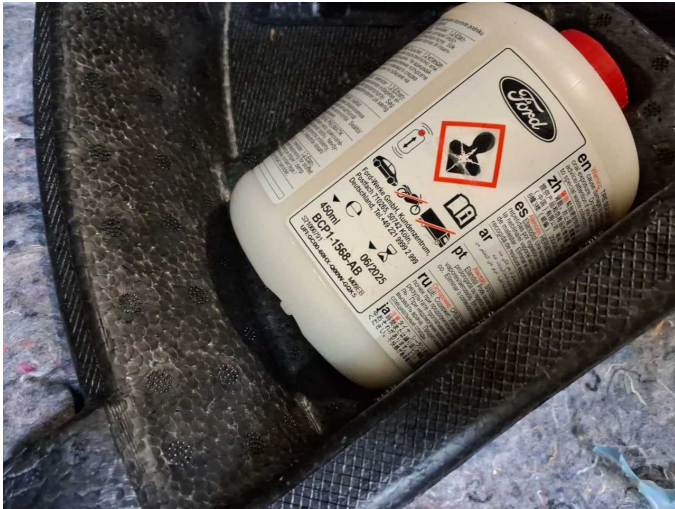
| No. | Component group | Description |
|---|---|---|
| 1 | Equipment | Tirefit filler - Expired - Replace |

**Damage 1:** Equipment: Tirefit filler - Expired - Replace

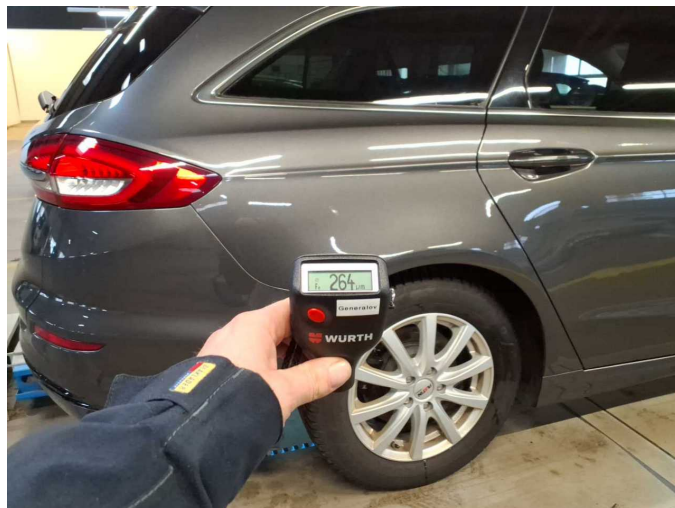
| No. | Repainting |
|---|---|
| 1 | Mudguard - right side, Professionally carried out, Invoice of repair done Non-existent |

**Repainting 1:** Mudguard - right side
