Expertise

Protocol number: 46566119  
Order No. / Reference: 26652716  
Inspection date: 16 Jul 2026

Manufacturer: Skoda  
VIN: TMBLR7NP0R7026412

Model: Superb Combi 2.0 TDI 4x4 DSG Style

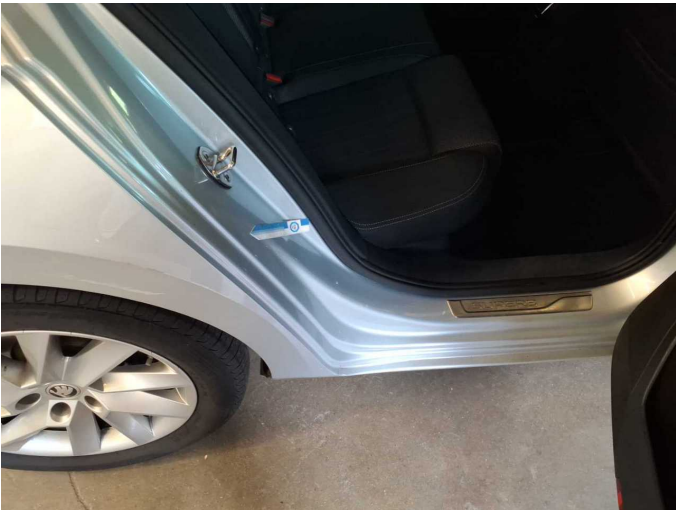
| No. | Component group | Description |
|---|---|---|
| 1 | Side panel - rear right side | Sill - dent(s) - Smooth repair work |

Damage 1: Side panel - rear right side: Sill - dent(s) - Smooth repair work

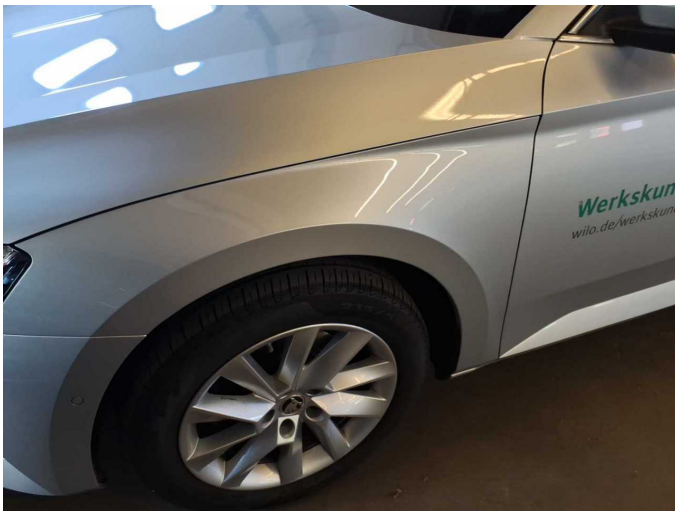
**Repainting 1:** Mudguard - left side
