Expertise

Protocol number: 46153695
Order No. / Reference: 26512589
Inspection date: 25 Jun 2026

Model: Enyaq iV 80

VIN: TMBJC9NY8NF042824

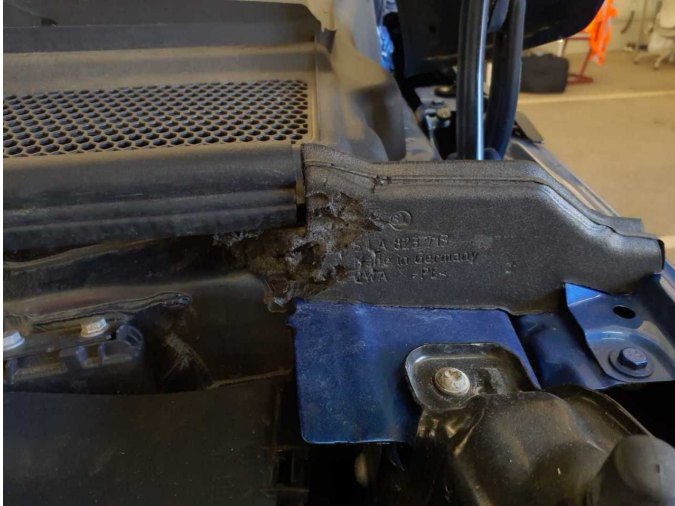
Damage 1: Cab: Insulation lining - Damage caused by marten / rodent - Replace
