Expertise

Protocol number: 46026933
Order No. / Reference: 26433632
Inspection date: 18 Jun 2026

Manufacturer: Ford

Model: Focus Turnier 2.0 EcoBlue Start-Stopp-System Aut.
COOL&CONNECT

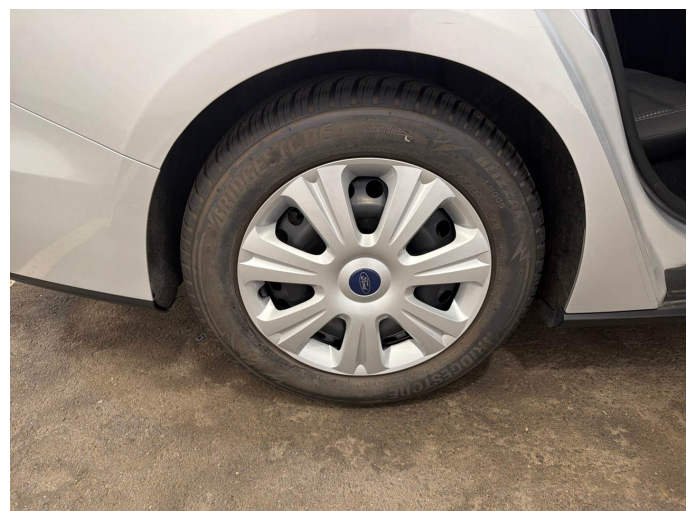
Figure 12: Mounted tyres

#	Tyre size	Type of tyre	Manufacturer	Tread depth
1)	205/60 R16 96H	Winter tyres on Steel rim with wheel cover	Bridgestone	6mm / 6mm
2)	205/60 R16 96H	Winter tyres on Steel rim with wheel cover	Bridgestone	6mm / 6mm

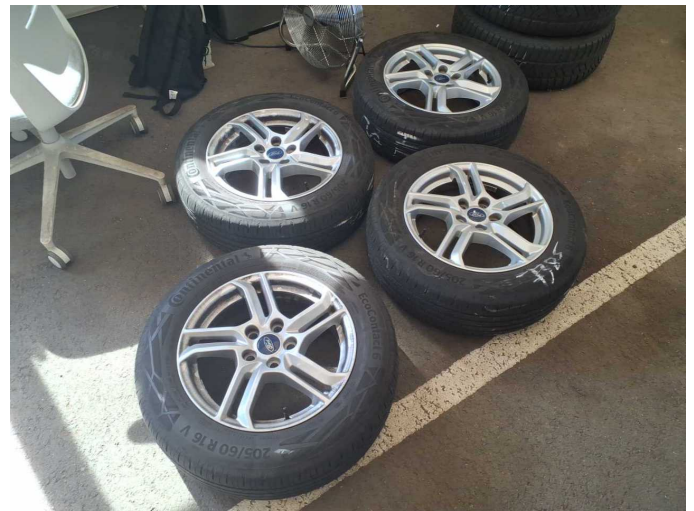
Figure 16: Additional tyres

#	Tyre size	Type of tyre	Manufacturer	Tread depth
1)	205/60 R16 92V	Summer tyres on Light alloy	Continental	6mm / 6mm
2)	205/60 R16 92V	Summer tyres on Light alloy	Continental	6mm / 6mm
