## Expertise

Protocol number: 45619243  
Order No. / Reference: 26152392  
Inspection date: 8 May 2026

Model: Vito 116 CDI Extralang HA PRO

VIN: W1VVLCEZ2S4451702

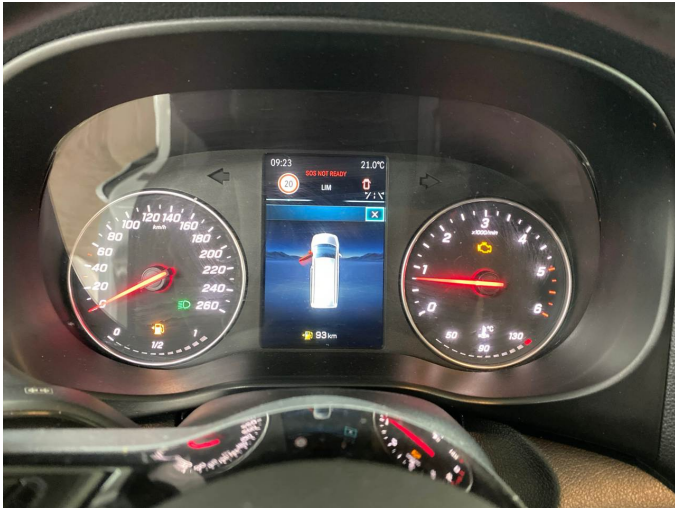
Figure 7: Instrument cluster

Documents submitted	At the time of the inspection, the vehicle registration certificate Part 2 (title) was available, but the vehicle registration certificate Part 1 (document) was not. (Copy)
VIN comparison	The vehicle identification number (VIN) was read from the vehicle and its conformity with the submitted documents was confirmed by the undersigned during the inspection.
Inspection	The inspection conditions were sufficient for the assessment of the vehicle. Lifting equipment and/or a pit were available for examining the vehicle.
Test drive	No test drive/shunting maneuver was carried out during the inspection of the vehicle.
Engine function test	An engine test run was performed, problem has been detected This is due to the following reason.: Motorkontrolle aktiv

**Damage 8:** Instrument panel: Indicator light (Motorkontrolle, nicht fahrbereit) - on - Perform diagnosis

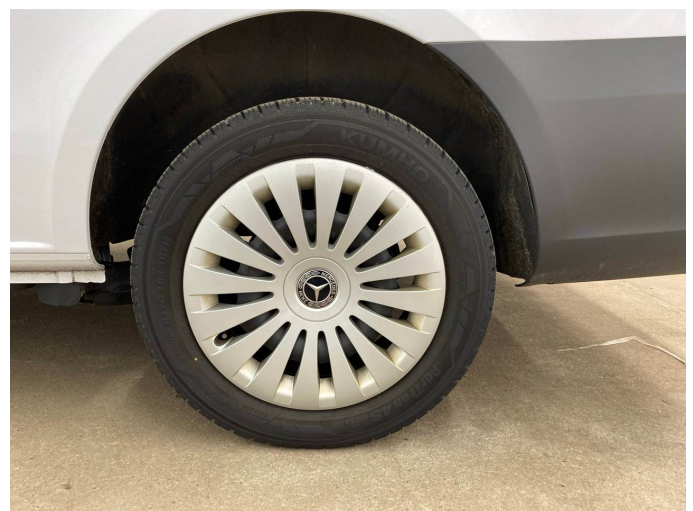
Figure 12: Mounted tyres

#	Tyre size	Type of tyre	Manufacturer	Tread depth
1)	225/55 R17 107H	All-season tyres on Steel rim with wheel cover	Kumho	6mm / 6mm
2)	225/55 R17 107H	All-season tyres on Steel rim with wheel cover	Kumho	6mm / 6mm
